Laser-Induced Damage Threshold (LIDT) Measurement Report

Damage Certification Test

Sample: Sample #1,2

Testing institute: Lidaris Ltd.
Saulėtekio al. 10,
LT-10223, Vilnius, Lithuania, EU

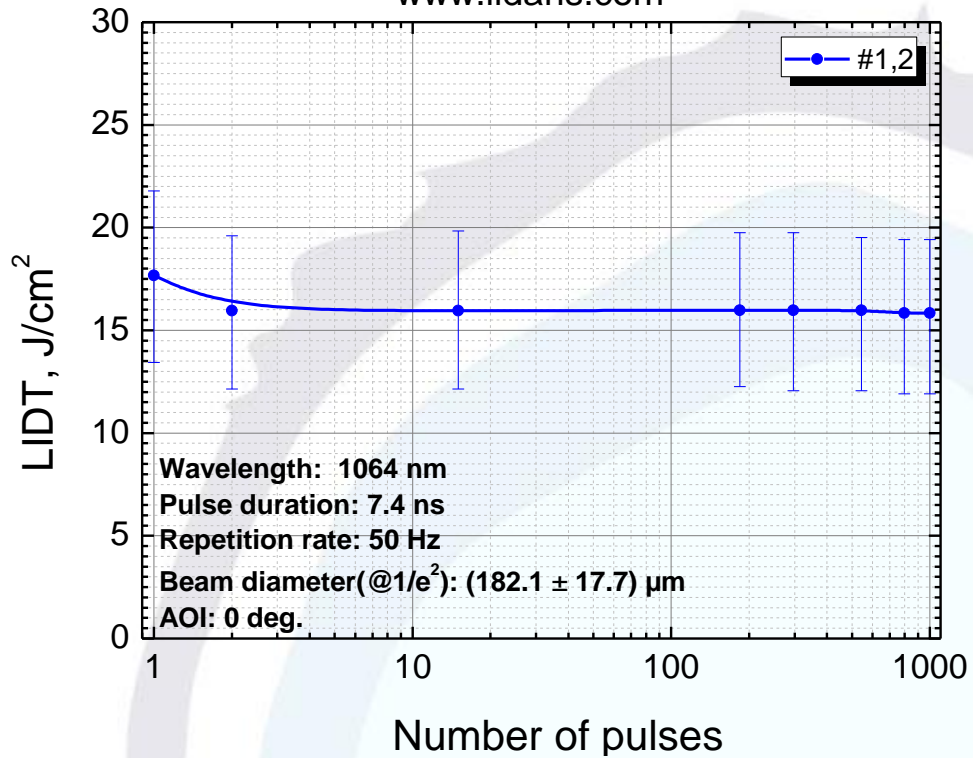
Fig. 2

Test mode	Threshold, J/cm ²
1-on-1	13.4 ≤ 17.7 ≤ 21.8
1000-on-1	11.9 ≤ 15.8 ≤ 19.4

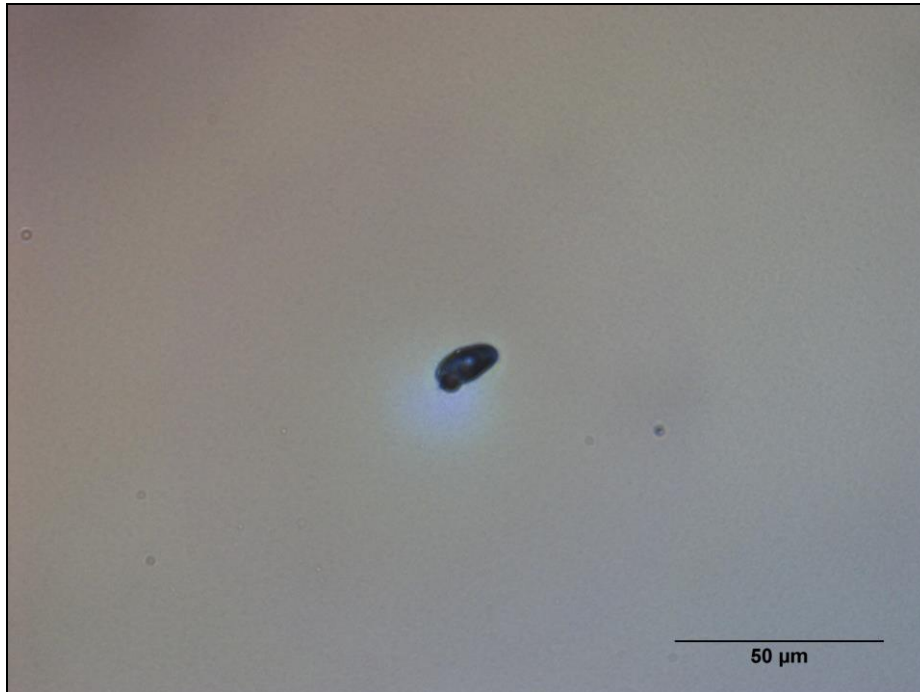
Fig. 3 Typical front surface damage morphology
(Energy density 17.7 J/cm^2 , damage after 1 pulse)

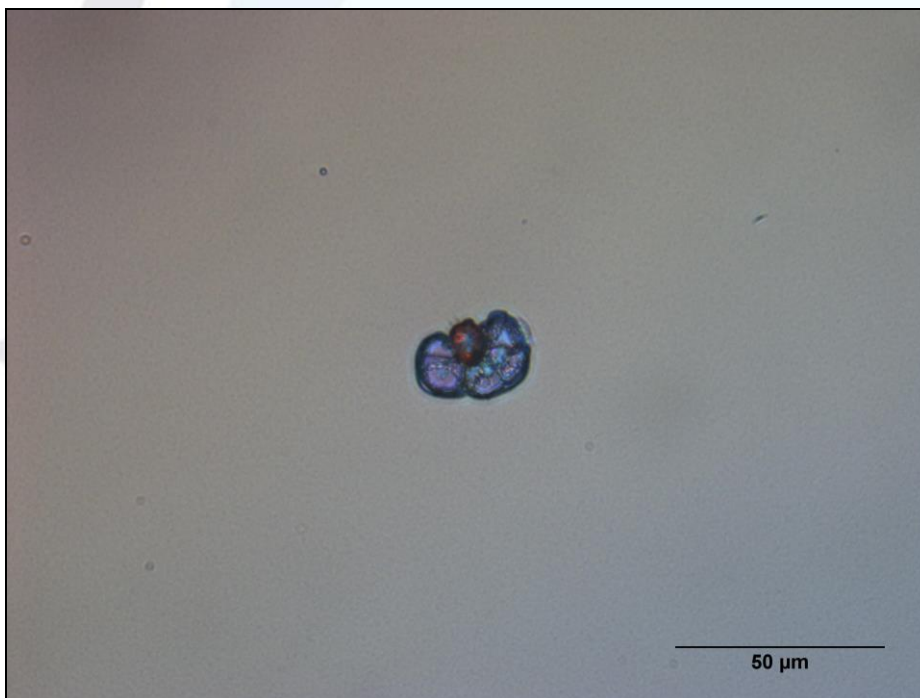
Fig. 4 Typical front surface damage morphology
(Energy density 17.73 J/cm^2 , damage after 18 pulses)
