Laser-Induced Damage Threshold (LIDT) Measurement Report

ISO 21254-2: S-on-1 Test Procedure

Sample: 2-CPW-ZO-L/2-0266

Testing institute: Lidaris Ltd.
Saulėtekio al. 10,
LT-10223, Vilnius, Lithuania, EU

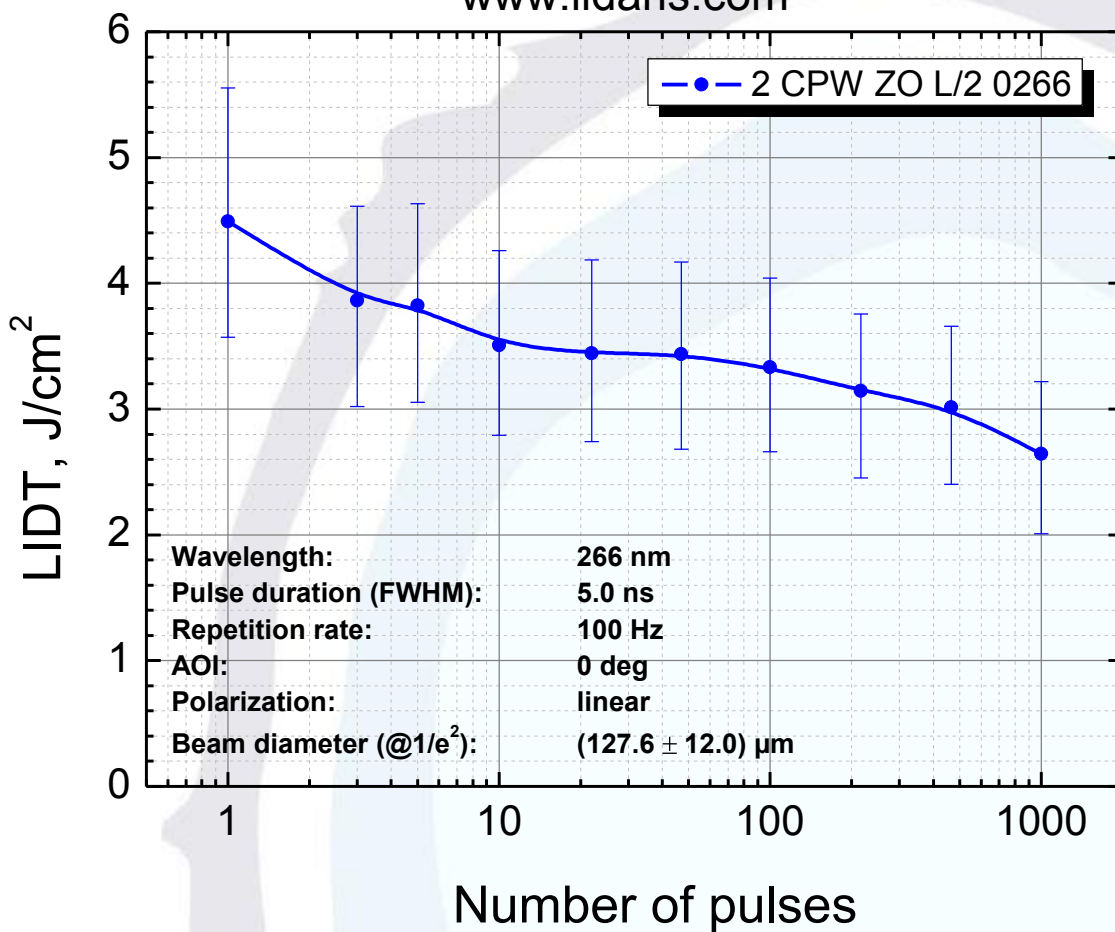
Test mode	Threshold, J/cm ²
1-on-1	$3.57 \leq 4.49 \leq 5.55$
1000-on-1	$2.01 \leq 2.65 \leq 3.22$

Fig. 2 Characteristic damage curve.

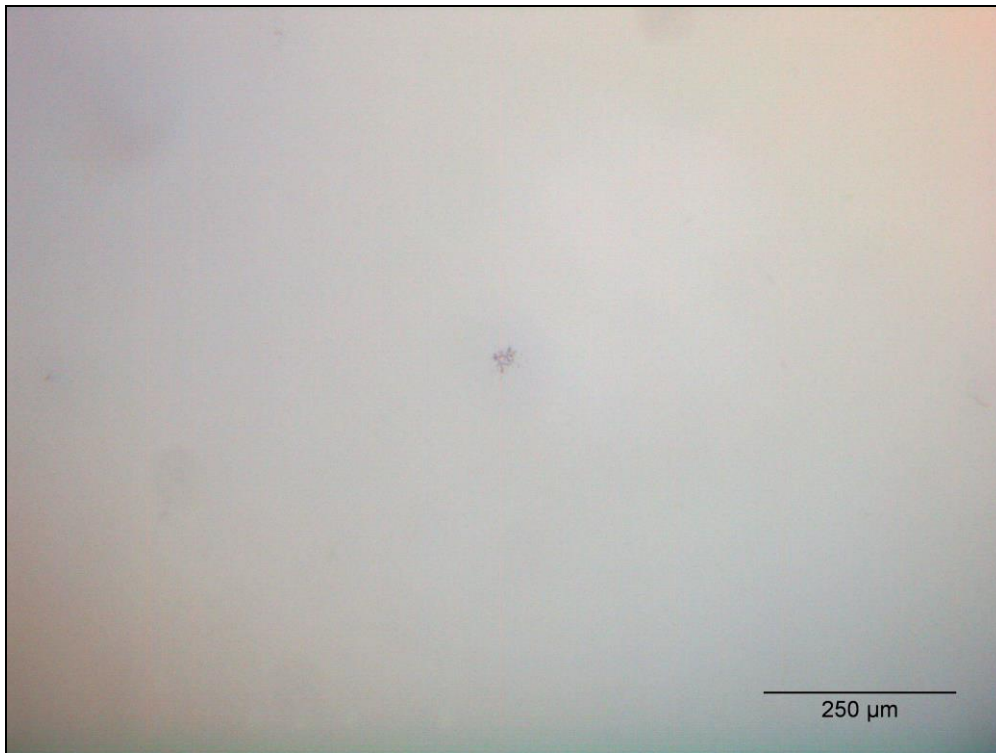
Fig. 3 Typical front surface damage morphology
(Energy density 5.34 J/cm², damage after 1 pulse)

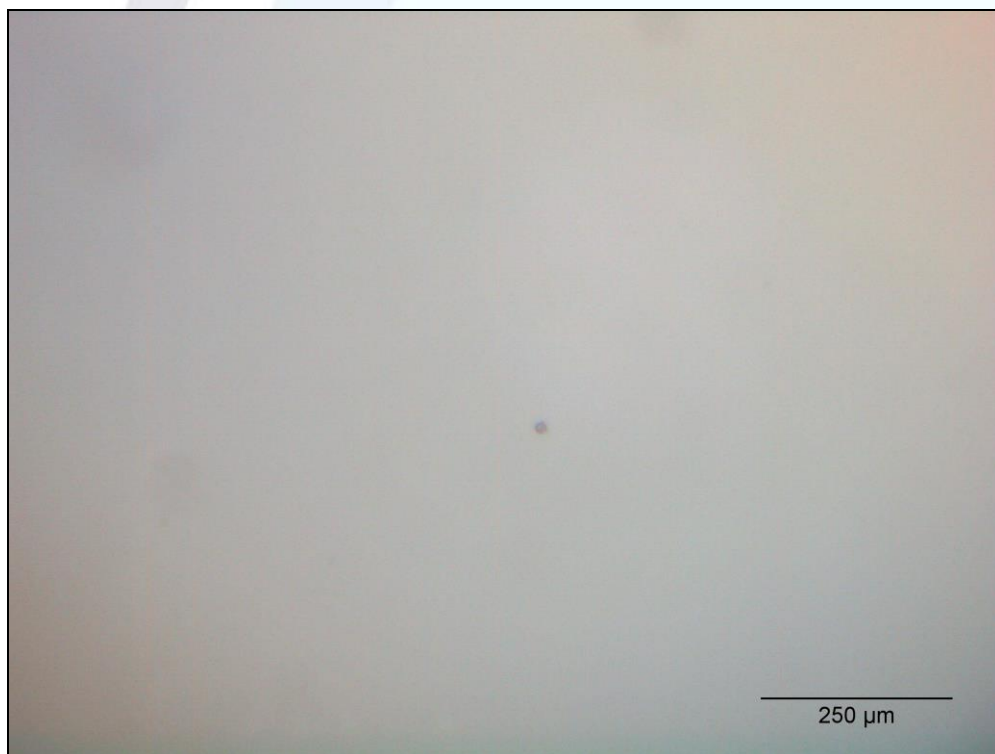
Fig. 4 Typical front surface damage morphology
(Energy density 2.71 J/cm², damage after 342 pulses)
