# Laser-Induced Damage Threshold (LIDT) Measurement Report

## ISO 21254-2: S-on-1 Test Procedure

Sample: 2-CPW-ZO-L/2-0532

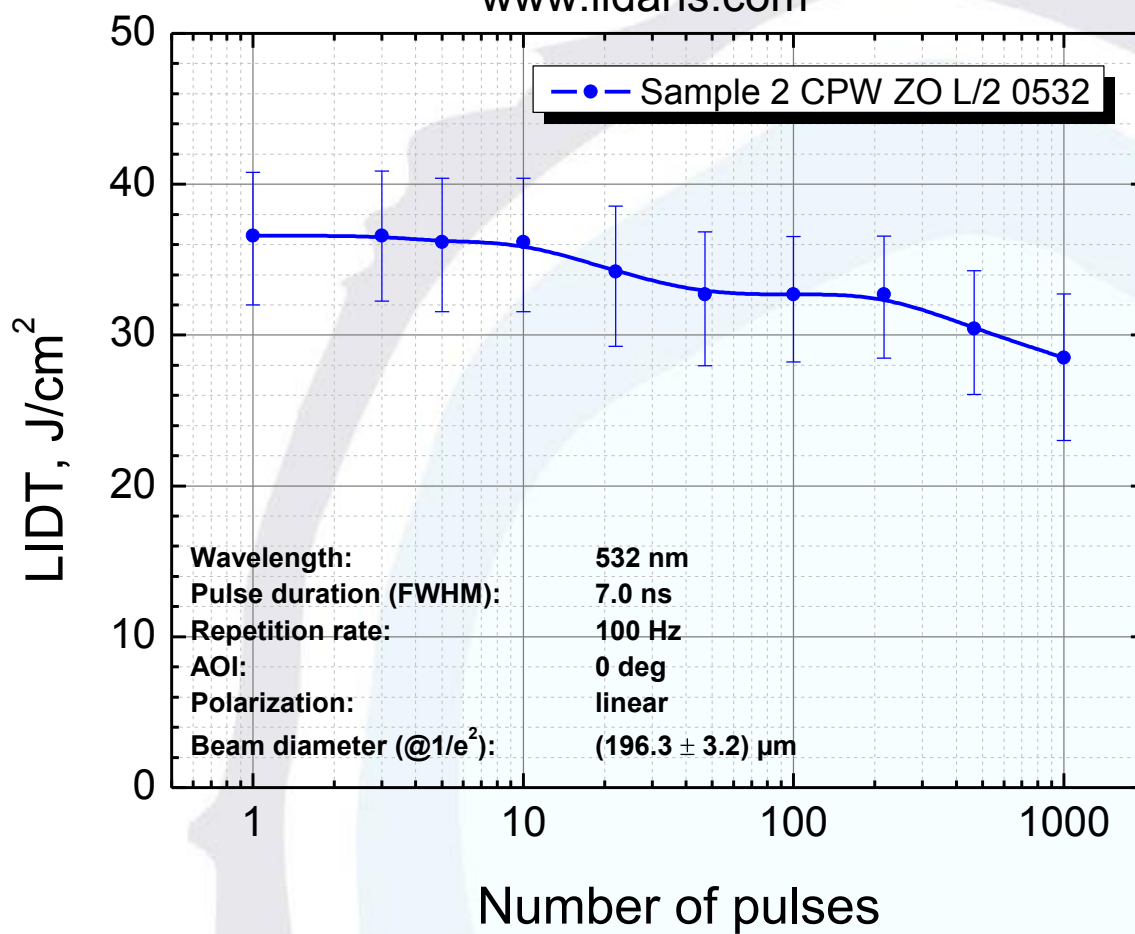
Test mode	Threshold, J/cm <sup>2</sup>
1-on-1	32.00 ≤ 36.59 ≤ 40.79
1000-on-1	23.01 ≤ 28.49 ≤ 32.72

Fig. 2 Characteristic damage curve.

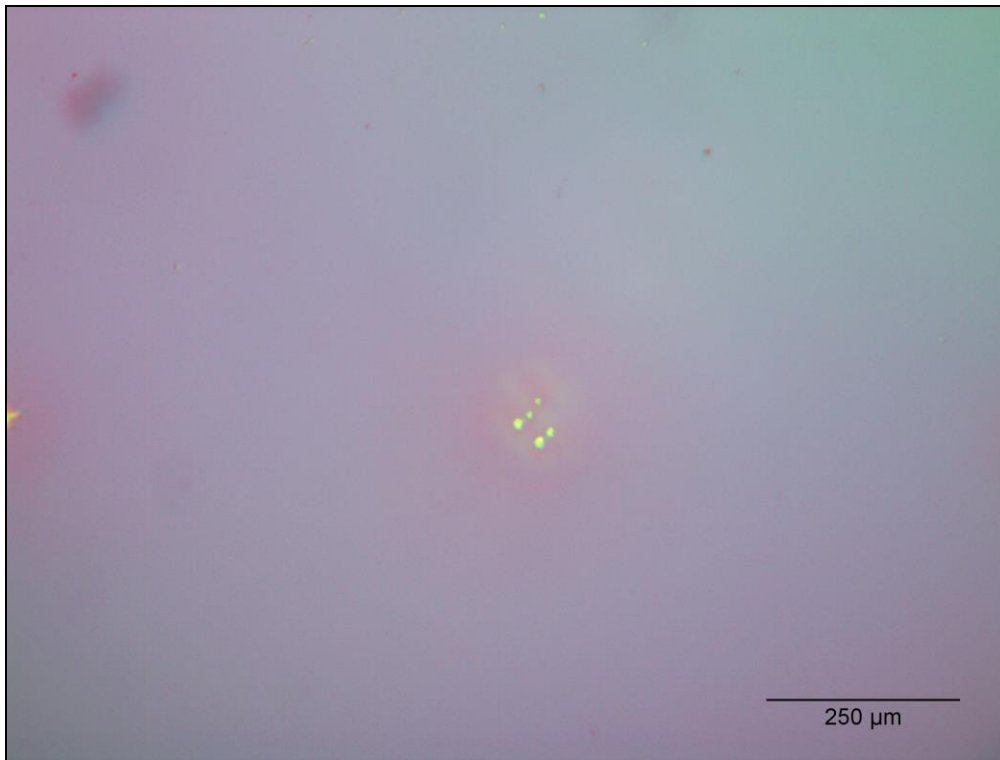
**Fig. 3 Typical front surface damage morphology  
(Energy density  $61.94 \text{ J/cm}^2$ , damage after 1 pulse)**

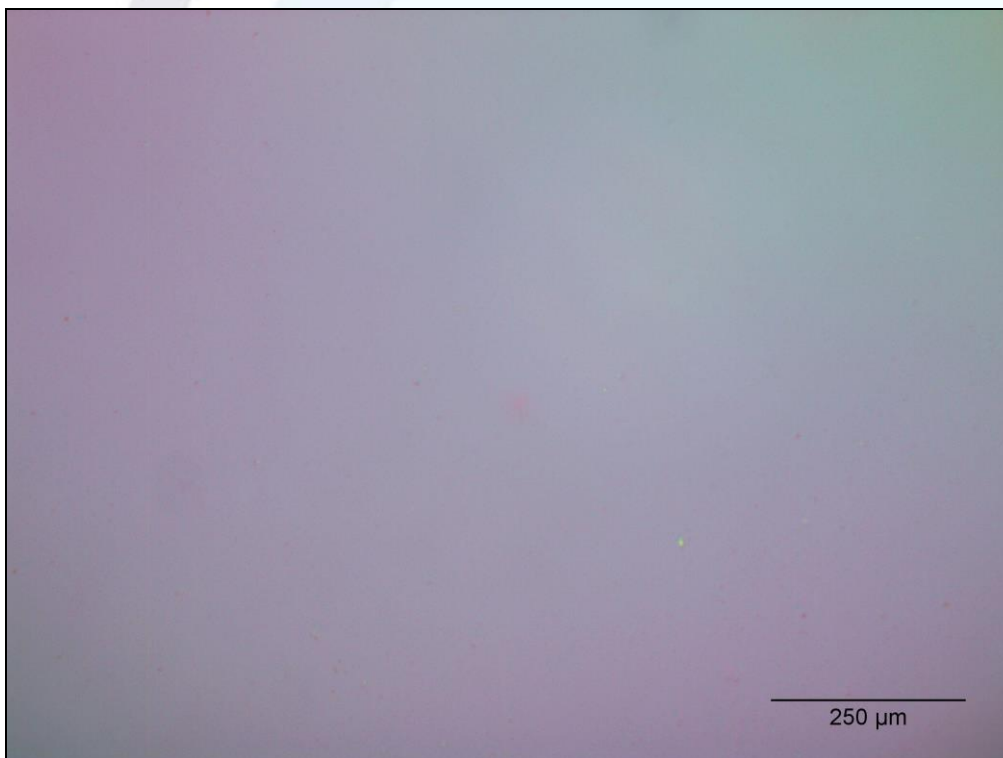
**Fig. 4 Typical in volume damage morphology  
(Energy density  $30.37 \text{ J/cm}^2$ , damage after 1000 pulses)**
