Laser-Induced Damage Threshold (LIDT) Measurement Report

ISO 21254-2: S-on-1 Test Procedure

Sample: 2-CPW-ZO-L/2-1030

Testing institute: Lidaris Ltd.
Saulėtekio al. 10,
LT-10223, Vilnius, Lithuania, EU

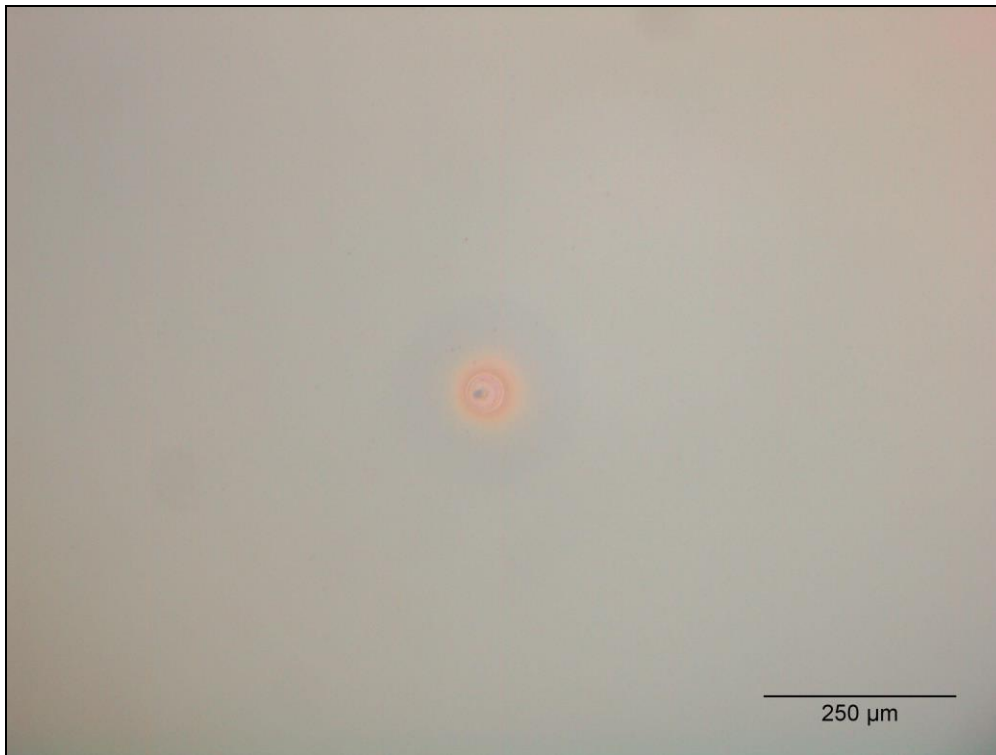
**Fig. 3 Typical in volume damage morphology
(Energy density 63.13 J/cm², damage after 1 pulse)**

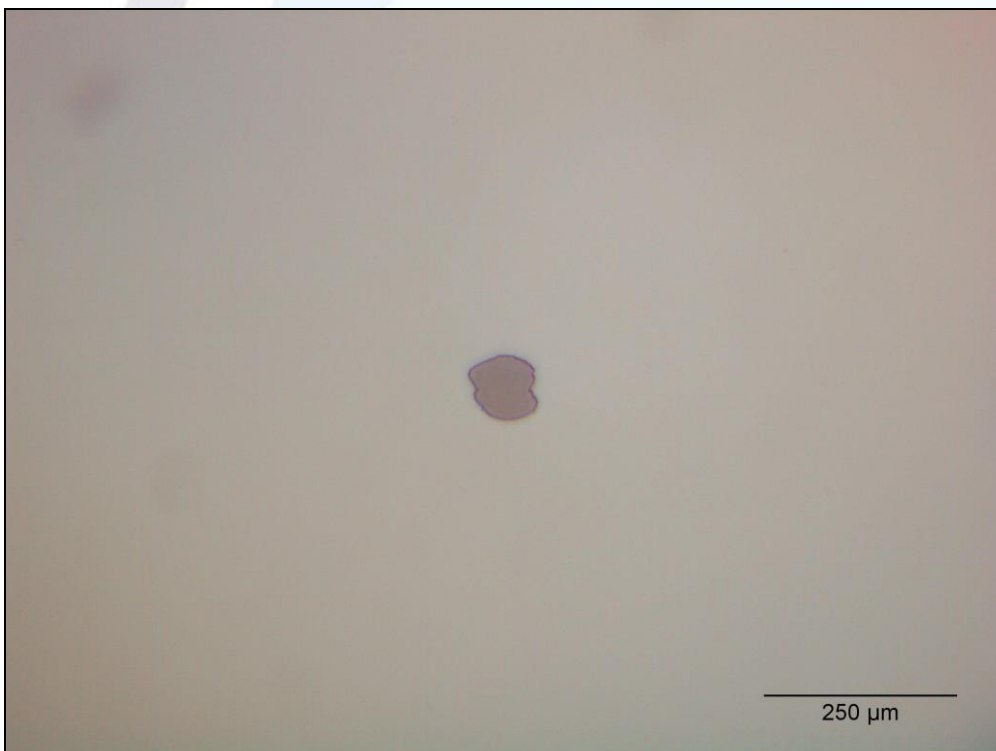
**Fig. 4 Typical front surface damage morphology
(Energy density 26.00 J/cm², damage after 1000 pulses)**
