Laser-Induced Damage Threshold (LIDT) Measurement Report

Damage Certification Test

Sample: Sample #5,2

Testing institute: Lidaris Ltd.
Saulėtekio al. 10,
LT-10223, Vilnius, Lithuania, EU

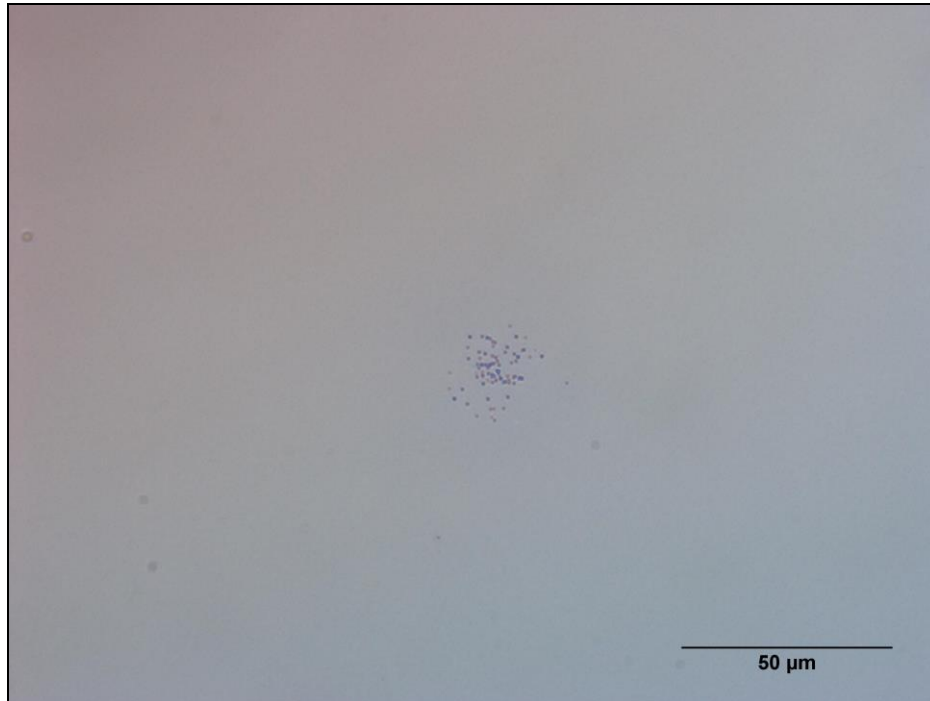
Fig. 3 Typical front surface damage morphology
(Energy density 3.12 J/cm^2 , damage after 1 pulse)

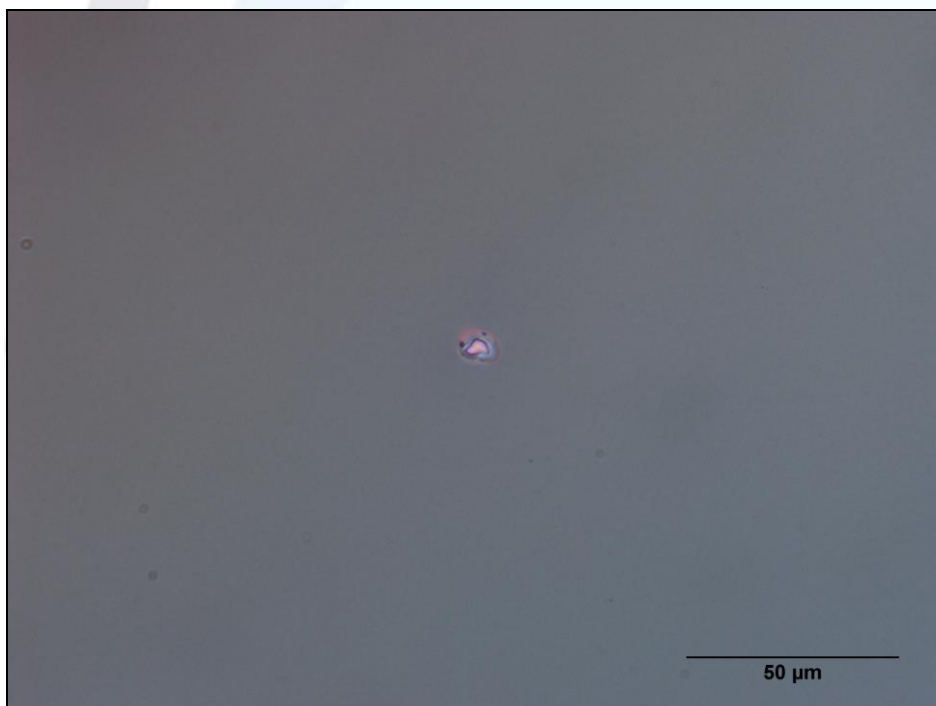
Fig. 4 Typical front surface damage morphology
(Energy density 1.16 J/cm^2 , damage after 390 pulses)
