# Laser-Induced Damage Threshold (LIDT) Measurement Report

## Damage Certification Test

Sample: Sample #4,2

**Testing institute:** Lidaris Ltd.  
Saulėtekio al. 10,  
LT-10223, Vilnius, Lithuania, EU

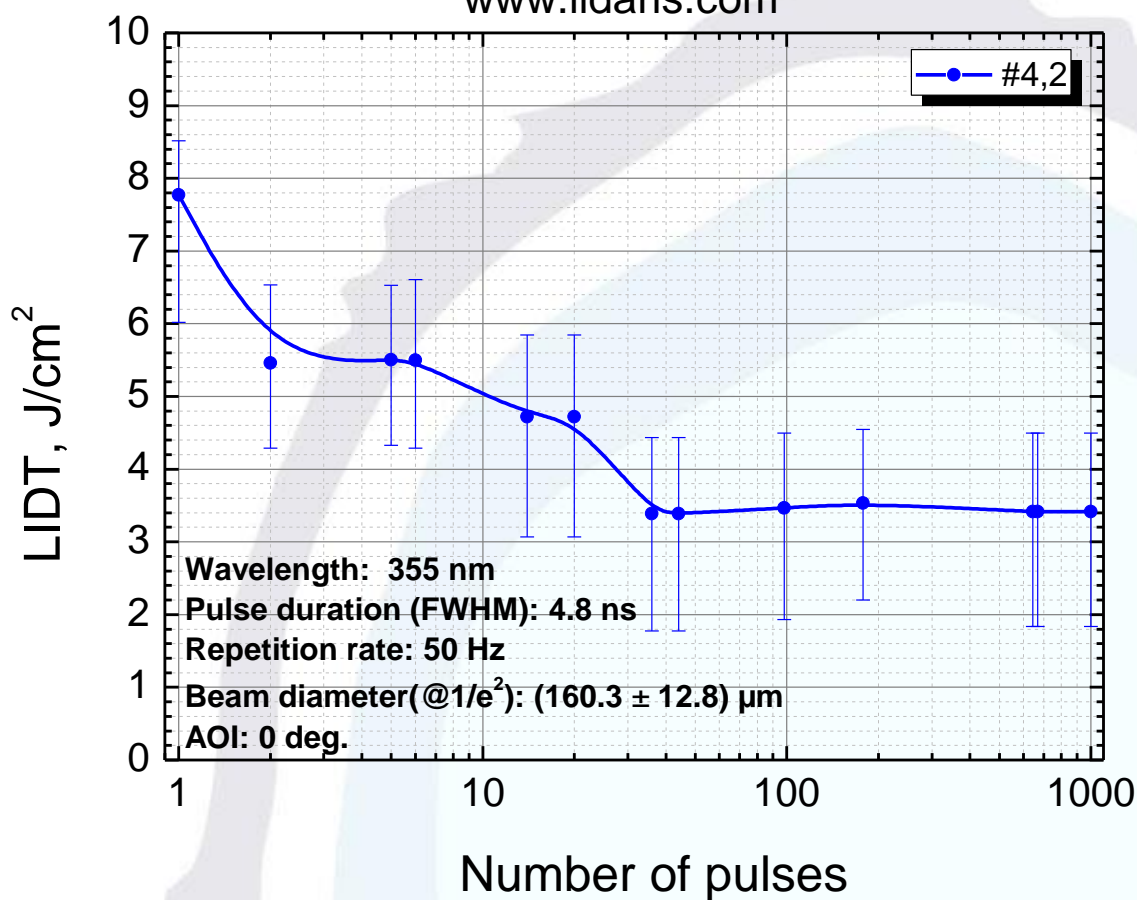
Fig. 2

Test mode	Threshold, J/cm <sup>2</sup>
1-on-1	$6.0 \leq 7.8 \leq 8.5$
1000-on-1	$1.8 \leq 3.4 \leq 4.5$

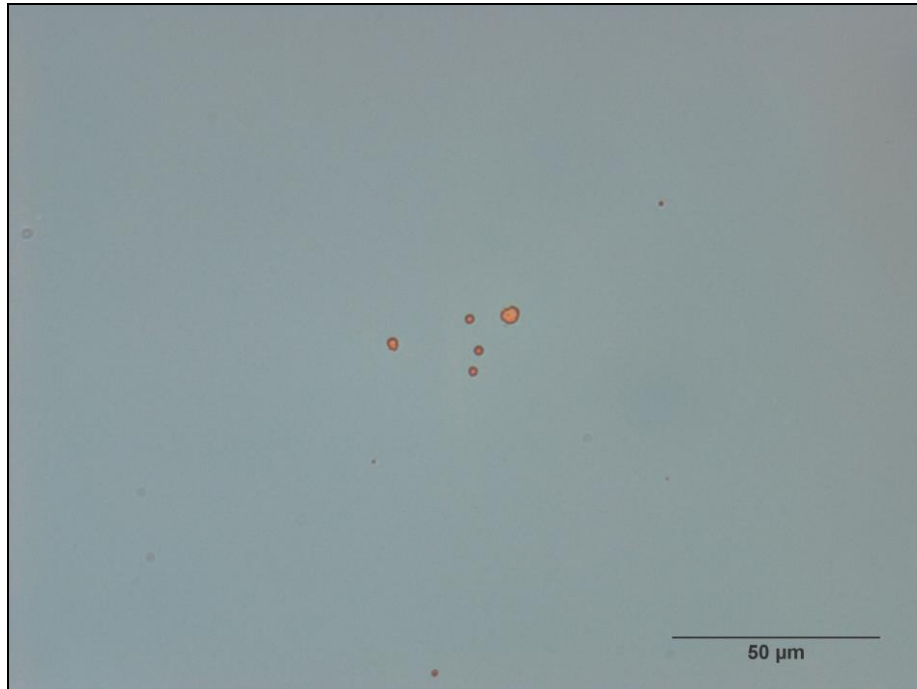
Fig. 3 Typical front surface damage morphology  
(Energy density  $7.61 \text{ J/cm}^2$ , damage after 1 pulse)

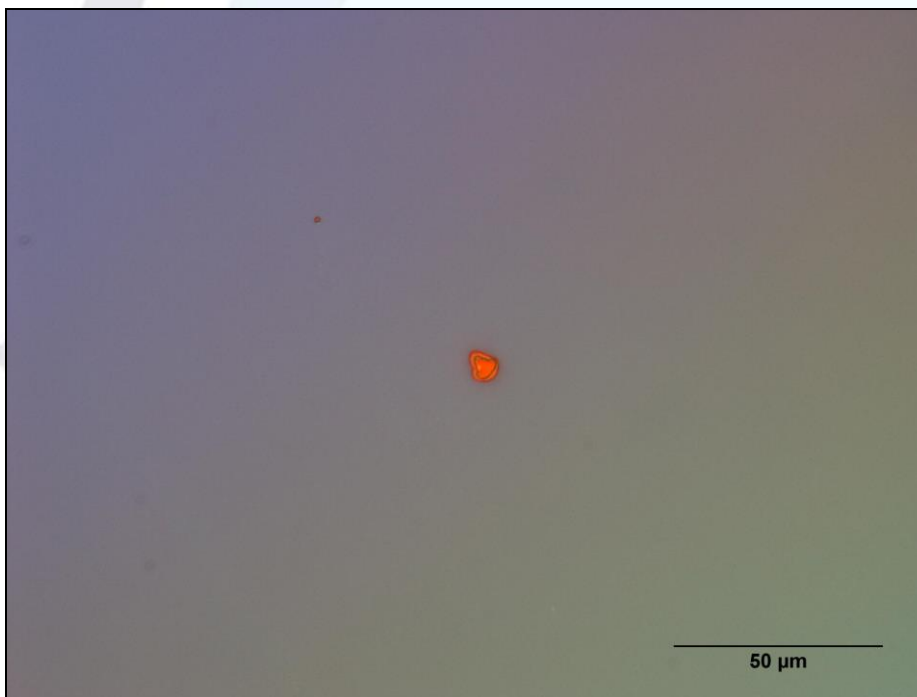
Fig. 4 Typical front surface damage morphology  
(Energy density  $3.70 \text{ J/cm}^2$ , damage after 43 pulses)
