Laser-Induced Damage Threshold (LIDT) Measurement Report

Damage Certification Test

Sample: Sample #3,2

Testing institute: Lidaris Ltd.
Saulėtekio al. 10,
LT-10223, Vilnius, Lithuania, EU

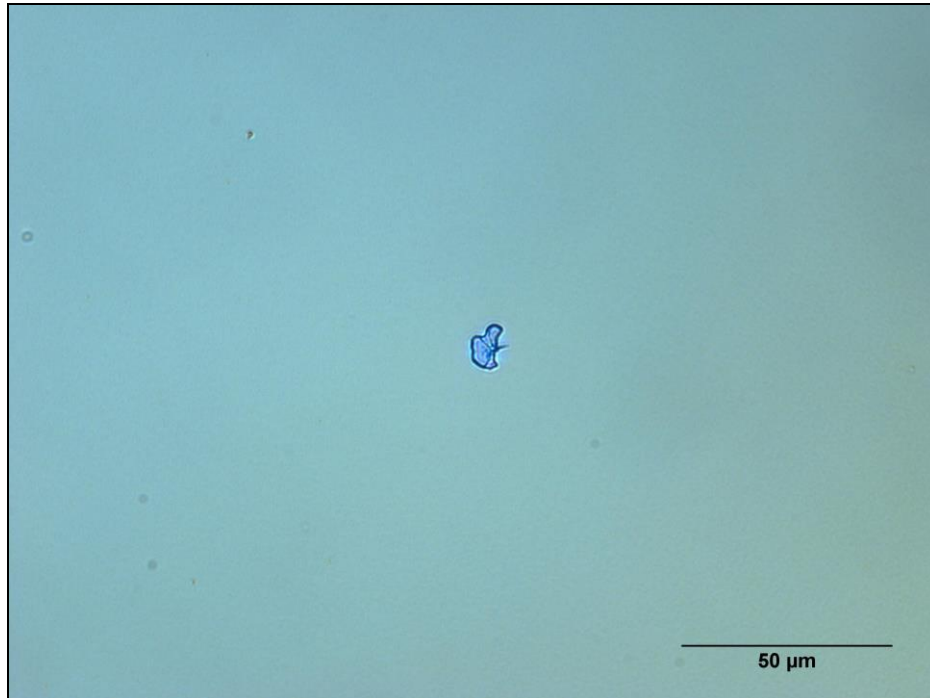
Fig. 3 Typical front surface damage morphology
(Energy density 33.07 J/cm^2 , damage after 1 pulse)

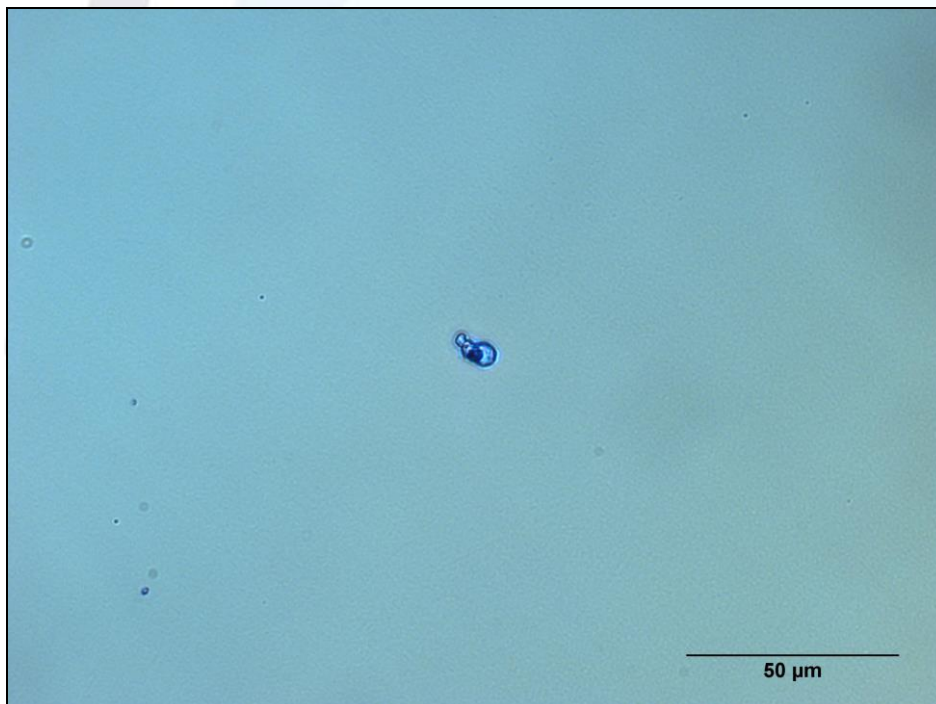
Fig. 4 Typical front surface damage morphology
(Energy density 13.54 J/cm^2 , damage after 24 pulses)
