Laser-Induced Damage Threshold (LIDT) Measurement Report

Damage Certification Test

Sample: Sample #2,2

Testing institute: Lidaris Ltd.
Saulėtekio al. 10,
LT-10223, Vilnius, Lithuania, EU

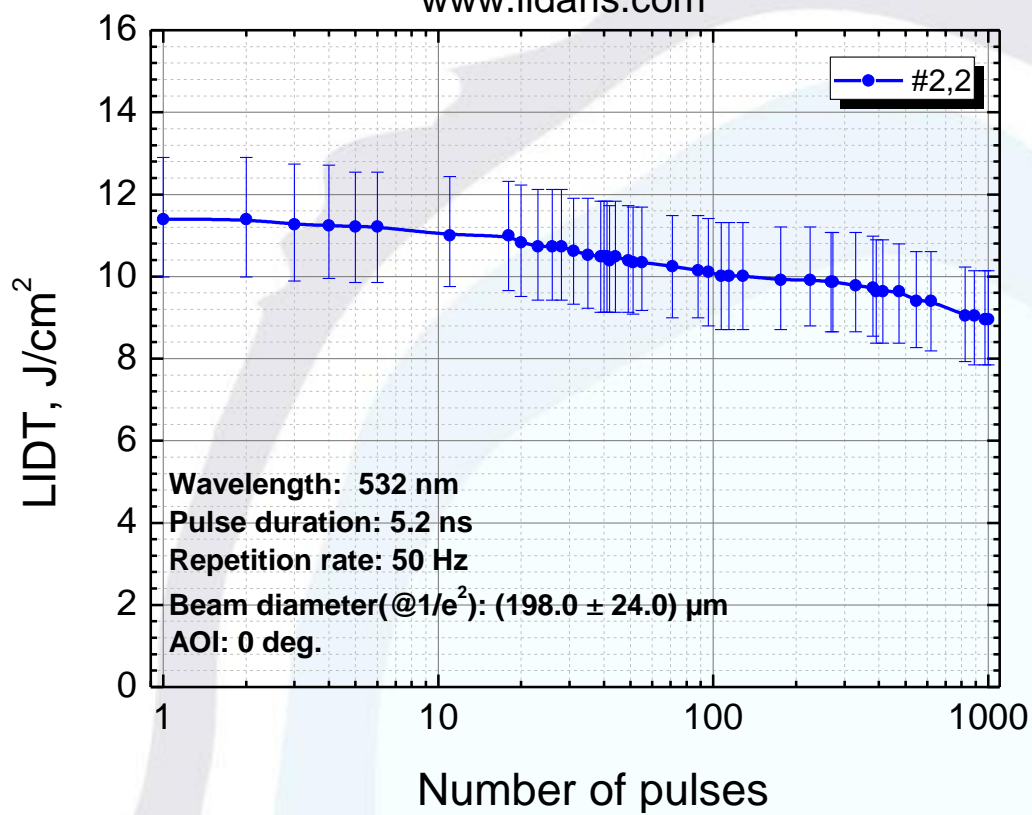
Fig. 2.

Test mode	Threshold, J/cm ²
1-on-1	10.0 ≤ 11.4 ≤ 12.9
1000-on-1	7.8 ≤ 9.0 ≤ 10.1

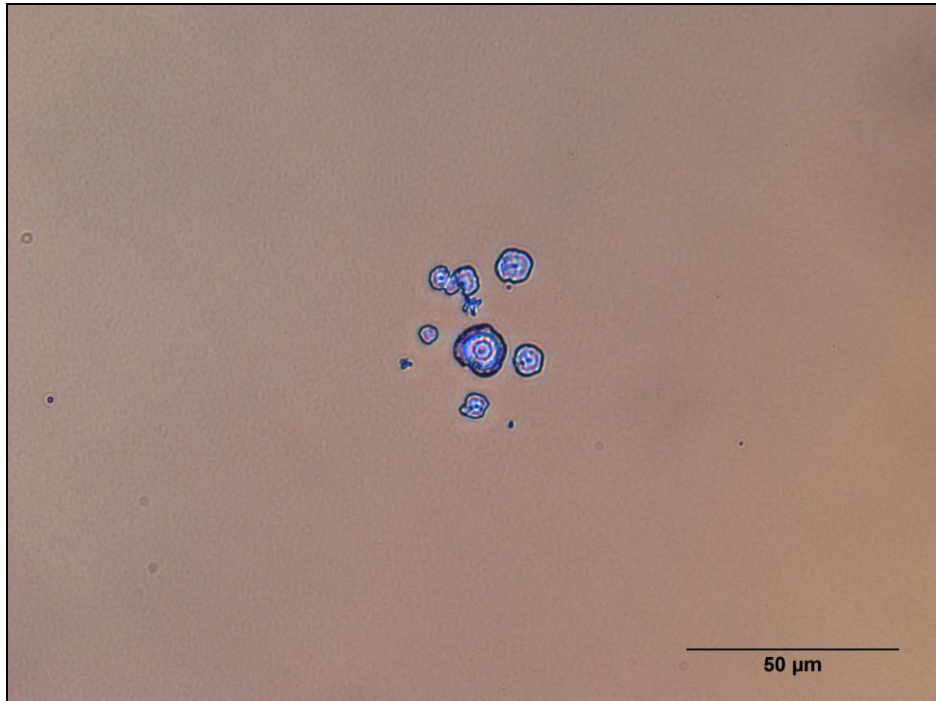
Fig. 3 Typical front surface damage morphology
(Energy density 7.91 J/cm^2 , damage after 1 pulse)

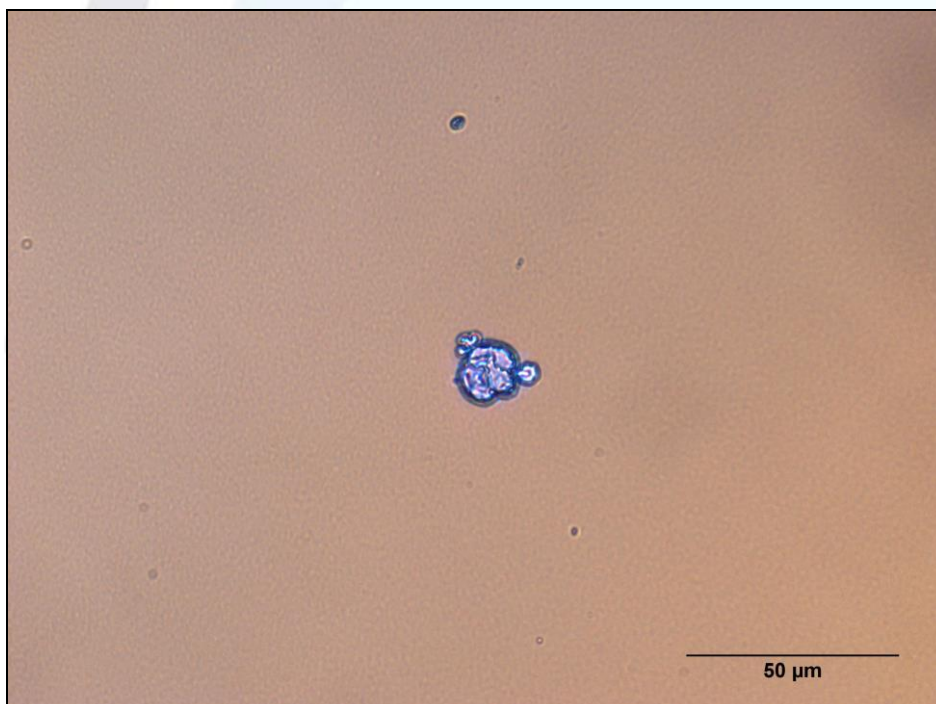
Fig. 4 Typical front surface damage morphology
(Energy density 14.65 J/cm^2 , damage after 825 pulses)
