Laser-Induced Damage Threshold (LIDT) Measurement Report

R-on-1 (Conditioning) Test Procedure

Sample: 10LDR15VV-LS

Testing institute: Lidaris Ltd.
Saulėtekio al. 10,
LT-10223, Vilnius, Lithuania, EU

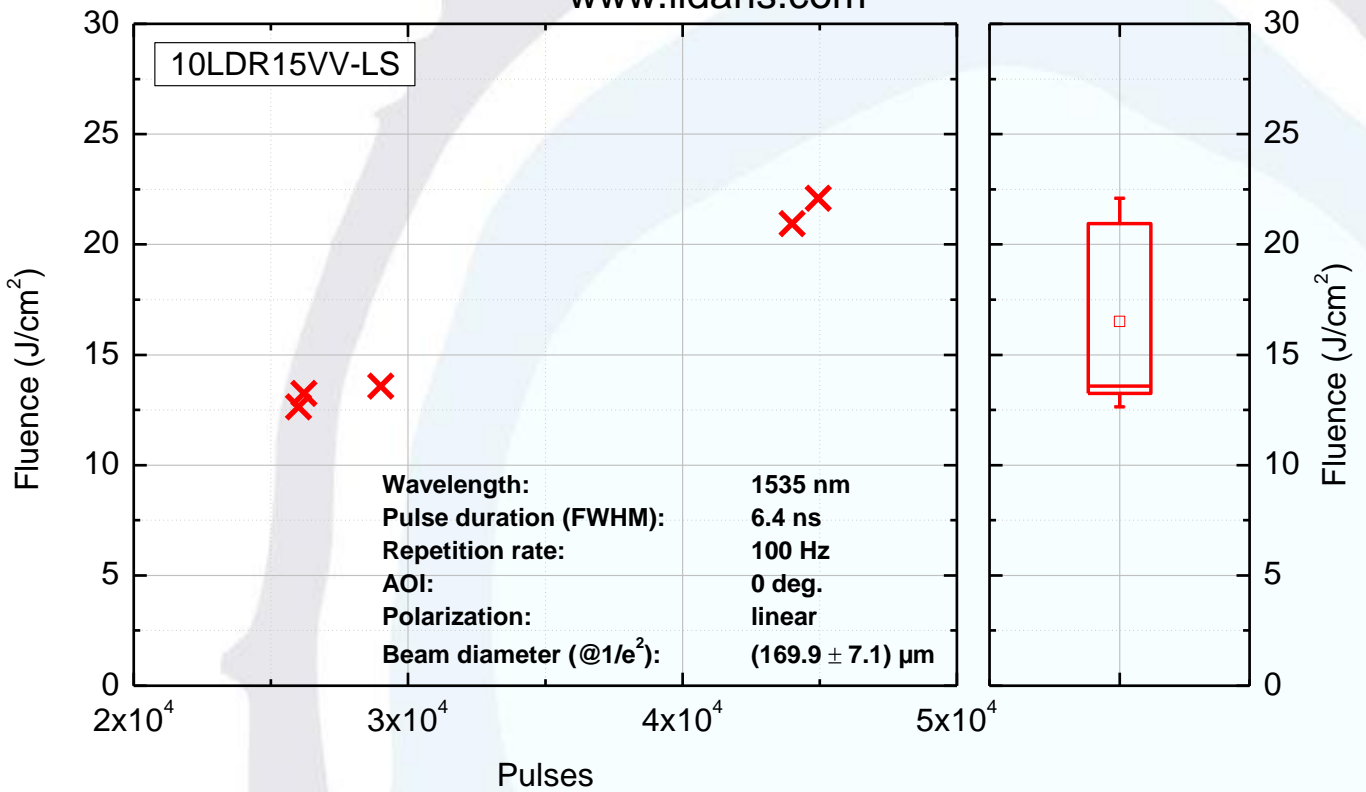
Fig. 2. R-on-1 test results

R-on-1	Front surface threshold, J/cm ²
Lowest observed damage	12.63 ± 1.23
Median observed damage	13.58 ± 1.32
Highest observed damage	22.09 ± 2.14

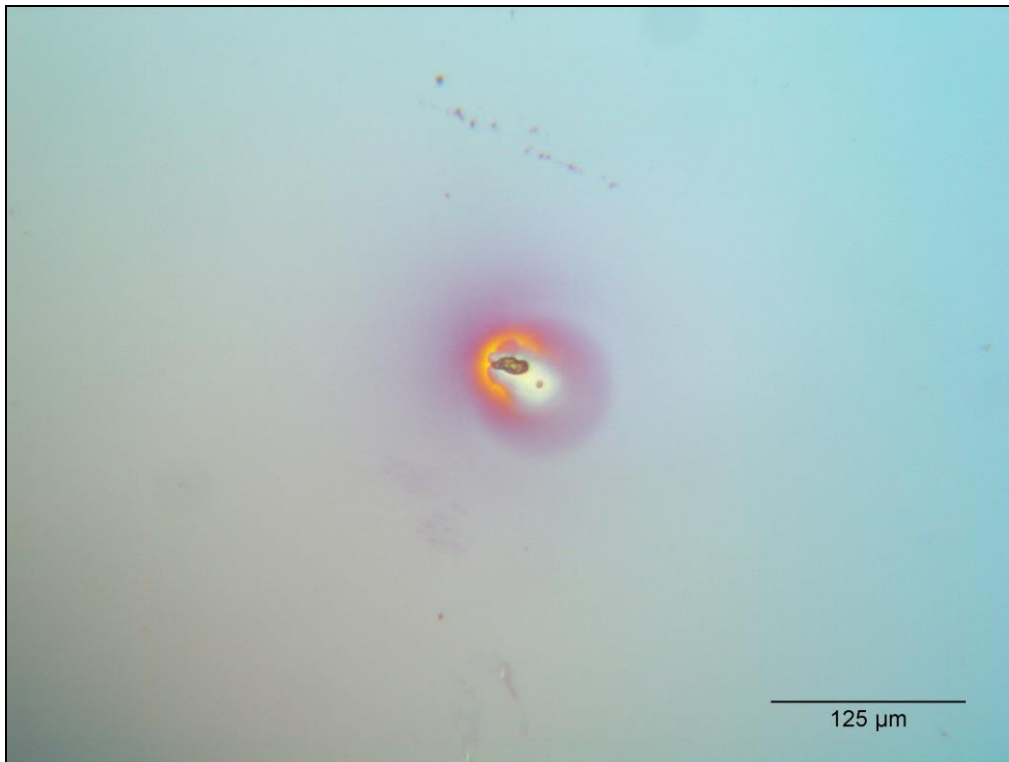
**Fig. 3 Typical front surface damage morphology
(Fluence 13.26 J/cm²)**

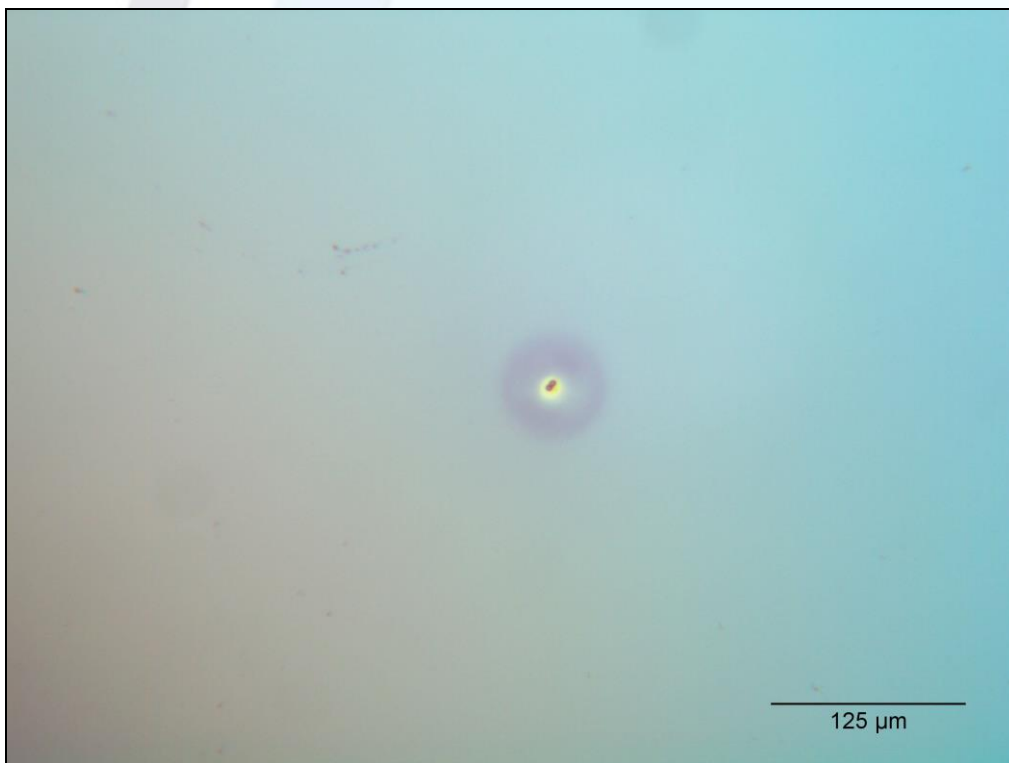
**Fig. 4 Typical front surface damage morphology
(Fluence 12.63 J/cm²)**
