LASER-INDUCED DAMAGE THRESHOLD (LIDT) MEASUREMENT REPORT

S-ON-1 (ISO 21254-2) TEST PROCEDURE

SAMPLE: SO_FS_10MM

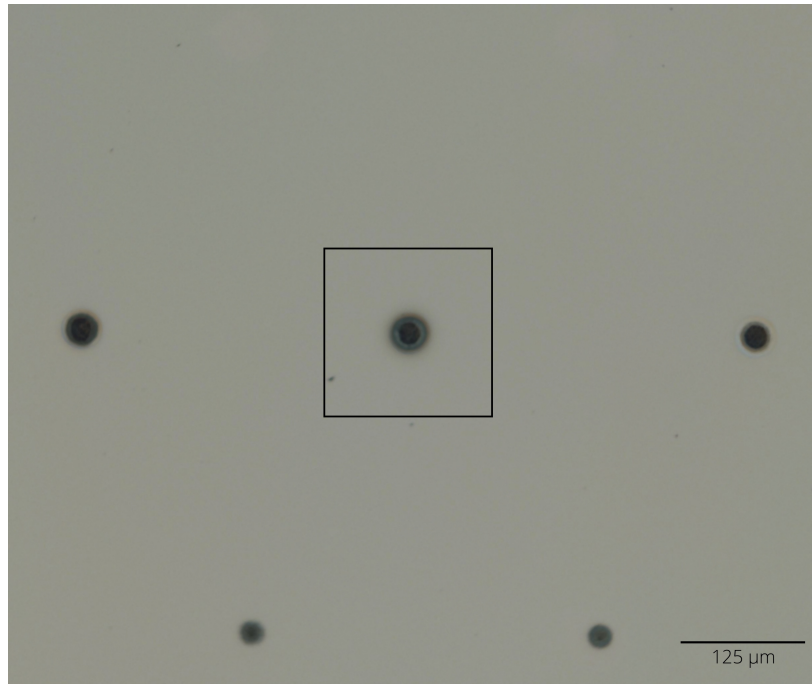
Figure 4. Typical damage morphology: fluence 3.58 J/cm^2 , damage after 8 pulse(s).

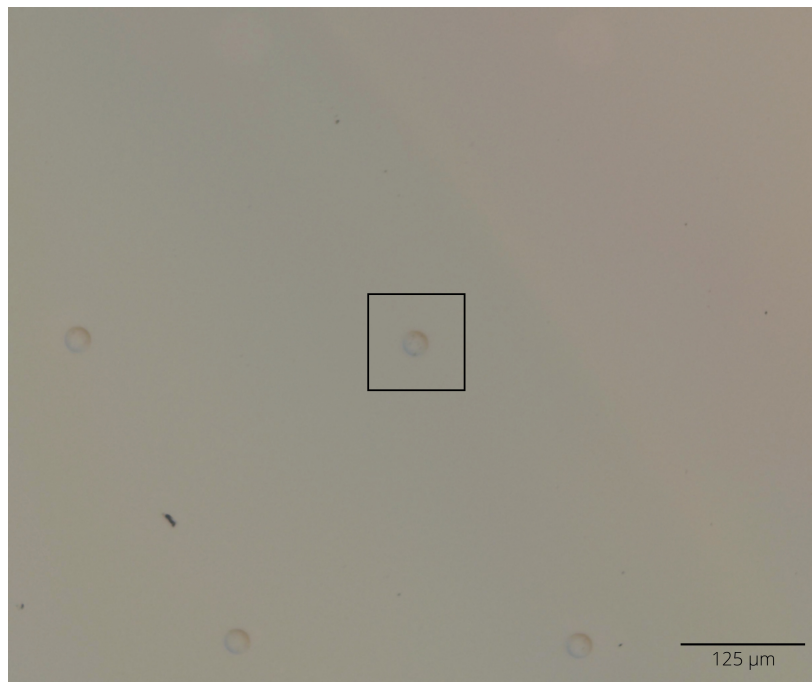
Figure 5. Typical damage morphology: fluence 4.03 J/cm^2 , damage after 1 pulse(s).

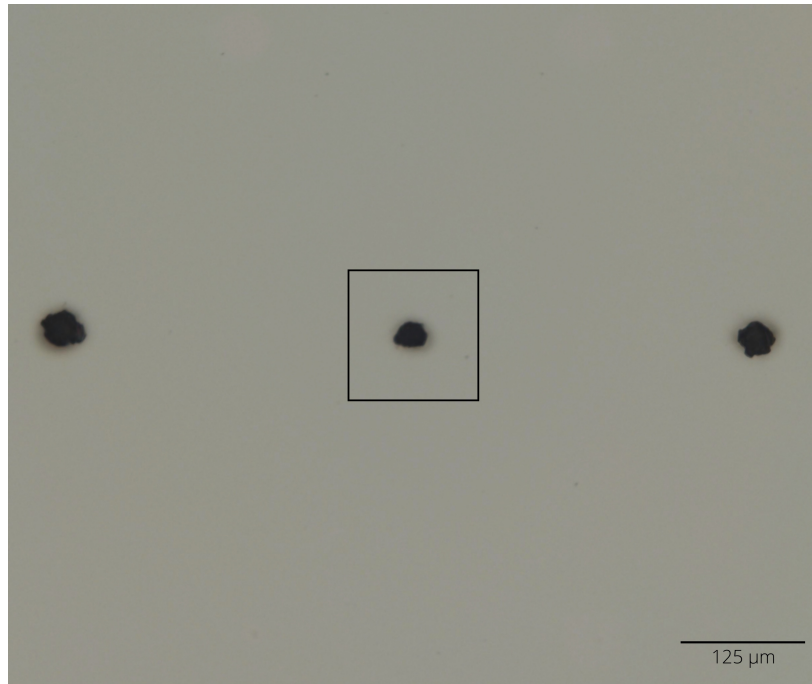
Figure 7. Typical damage morphology: fluence 2.36 J/cm^2 , damage after 598 pulse(s).

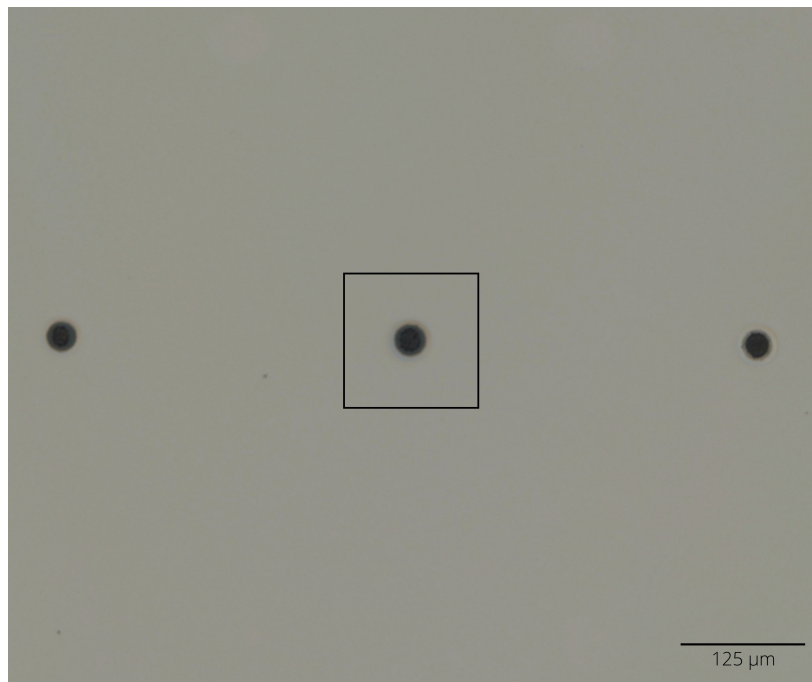
Figure 8. Typical damage morphology: fluence 3.59 J/cm^2 , damage after 8 pulse(s).
