Laser-Induced Damage Threshold (LIDT) Measurement Report

ISO21254-2: S-on-1 Test Procedure

Sample: 2-CPW-ZO-L/2-0800

Testing institute: Lidaris Ltd.
Saulėtekio al. 10,
LT-10223, Vilnius, Lithuania, EU

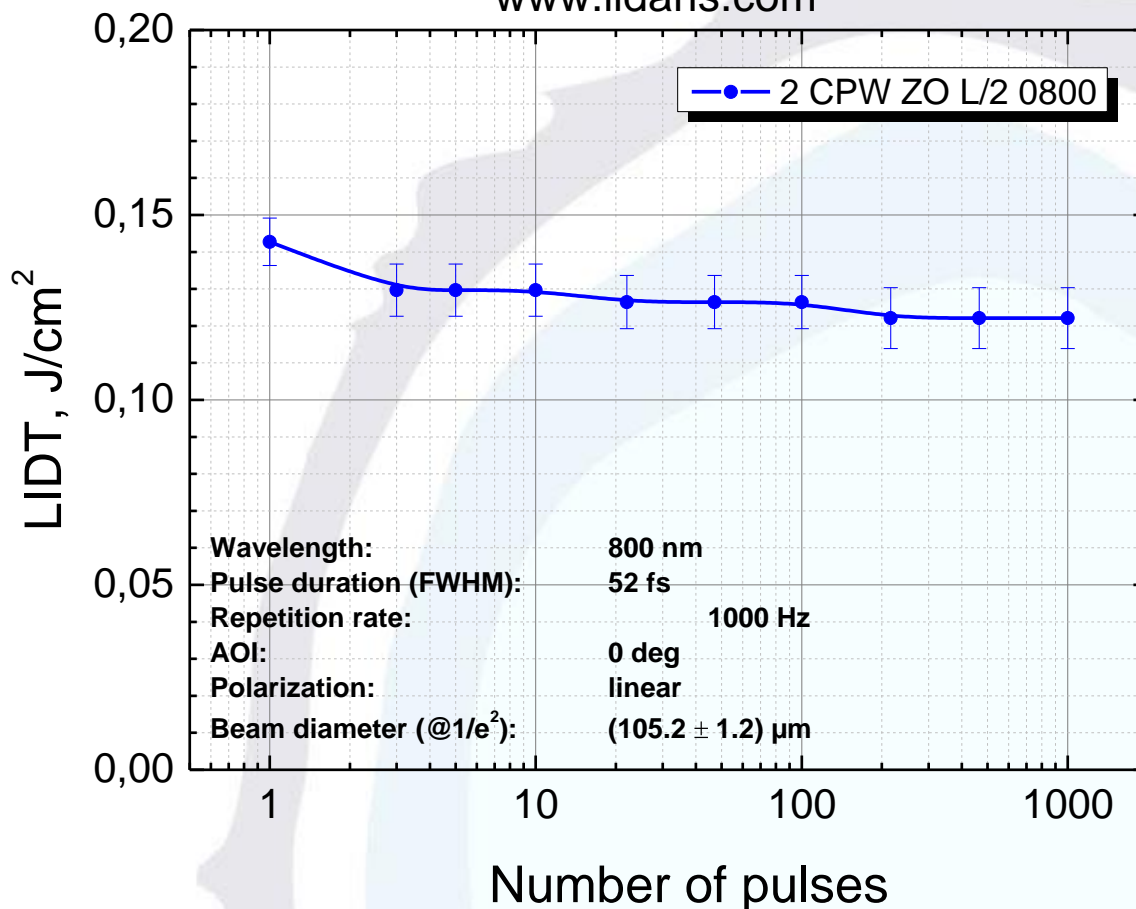
Test mode	Threshold, J/cm ²
1-on-1	0.143 ± 0.006
1000-on-1	0.122 ± 0.008

Fig. 3. Characteristic damage curve.

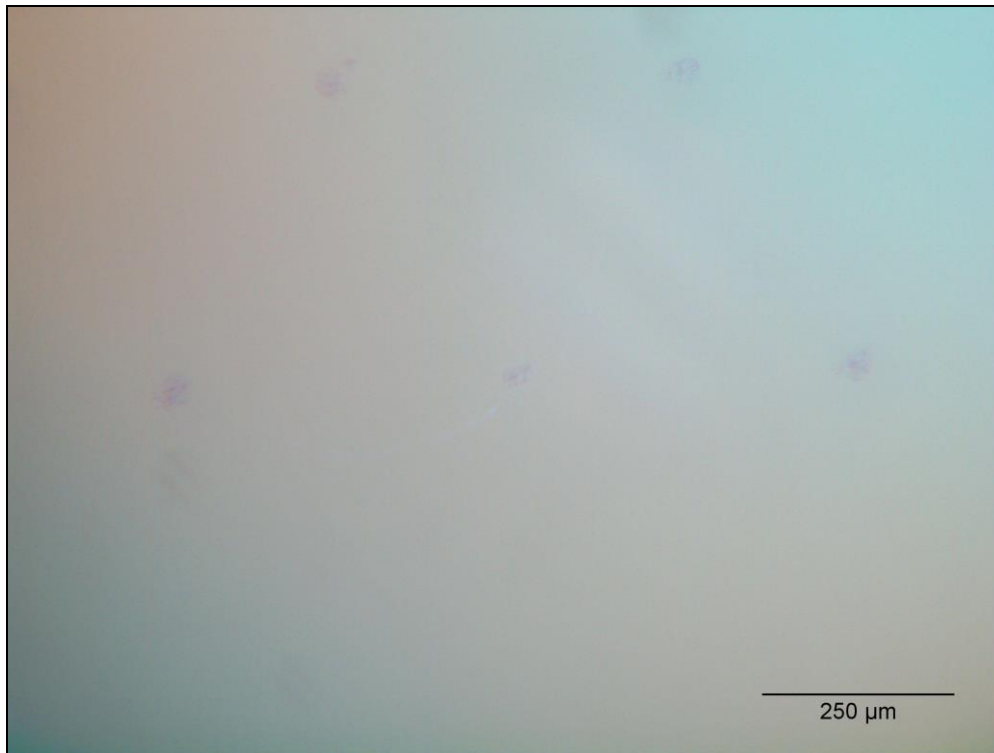
Fig. 4. Typical front surface damage morphology
(Energy density 0.30 J/cm^2 , damage after 1 pulse)

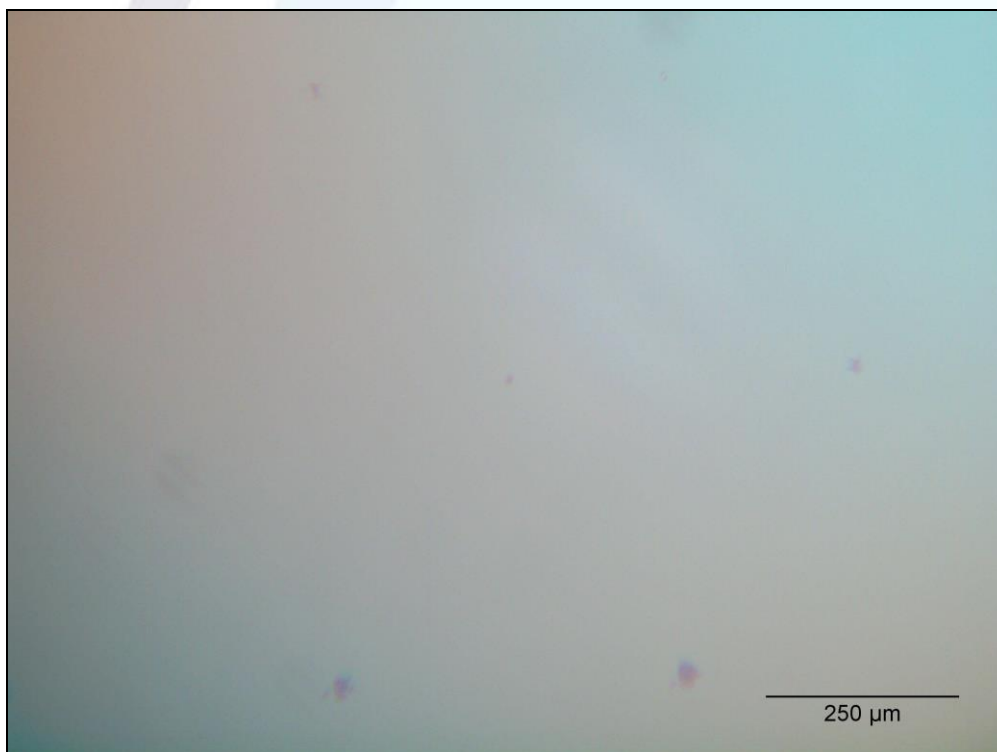
Fig. 5. Typical front surface damage morphology
(Energy density 0.12 J/cm^2 , damage after 1000 pulses)
