Laser-Induced Damage Threshold (LIDT) Measurement Report

ISO 21254-2: S-on-1 Test Procedure

Sample: 2-HPCB-C-0125

Type of specimen: Polarizing Cube for High Energy Applications

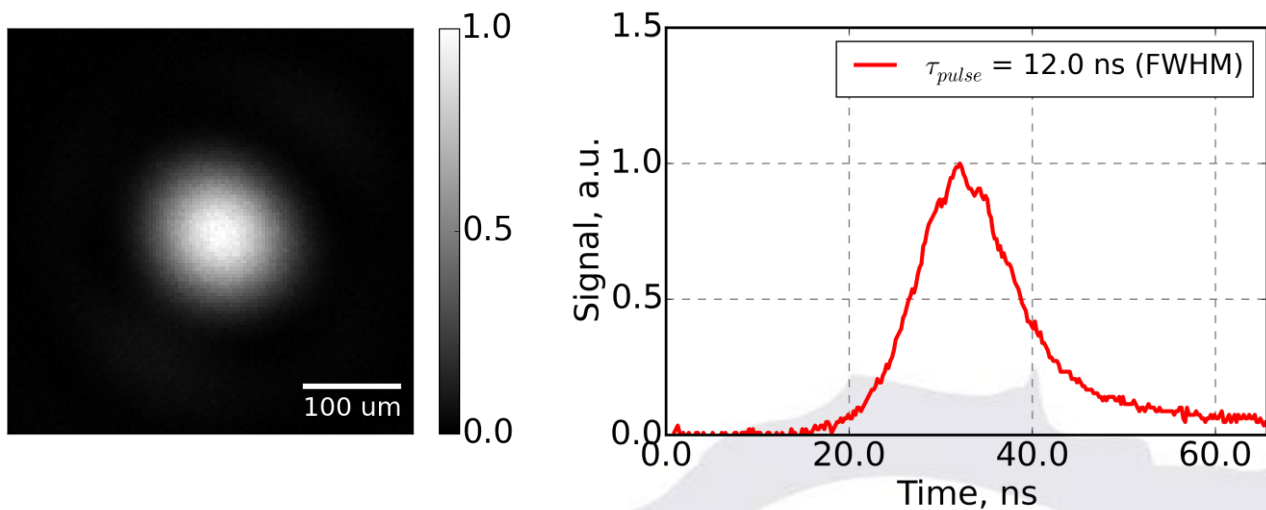
Fig. 1 Spatial beam profile in target plane (left) and temporal pulse profile (right)

Wavelength: 1064 nm
Angle of incidence: 0 deg.
Polarization state: linear P
Pulse repetition frequency: 100 Hz
Spatial beam profile in target plane: TEM₀₀
Longitudinal beam profile: Single mode (SLM)
Beam diameter in target plane ($1/e^2$): (196.8 ± 2.6) μm (average from 500 pulses)
Pulse duration: (12.0 ± 0.4) ns

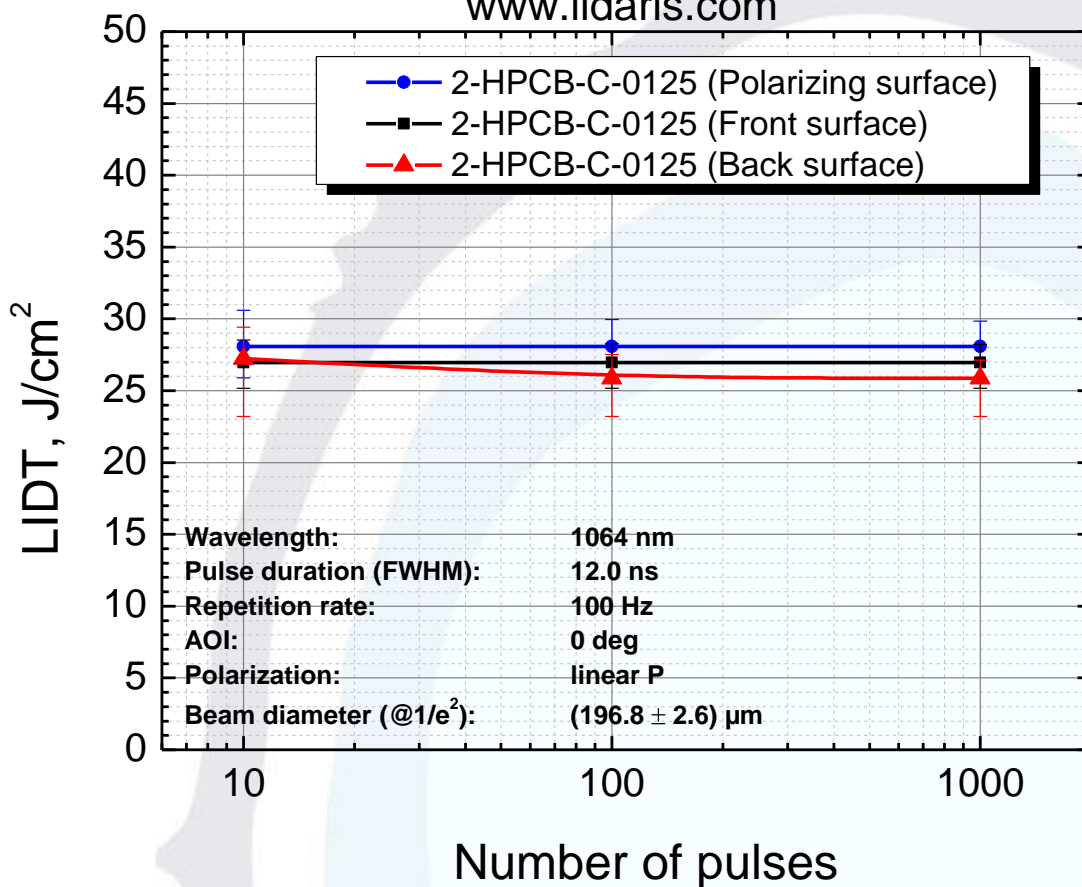
Fig. 2 Characteristic damage curve.

Test mode	Polarizing surface threshold, J/cm ²	Front surface threshold, J/cm ²	Back surface threshold, J/cm ²
10-on-1	25.9 ≤ 28.1 ≤ 30.6	25.2 ≤ 27.0 ≤ 28.5	23.2 ≤ 27.3 ≤ 29.4
100-on-1	25.9 ≤ 28.1 ≤ 30.0	25.2 ≤ 27.0 ≤ 28.3	23.2 ≤ 25.9 ≤ 27.5
1000-on-1	25.9 ≤ 28.1 ≤ 29.9	25.2 ≤ 27.0 ≤ 28.2	23.2 ≤ 25.9 ≤ 27.1

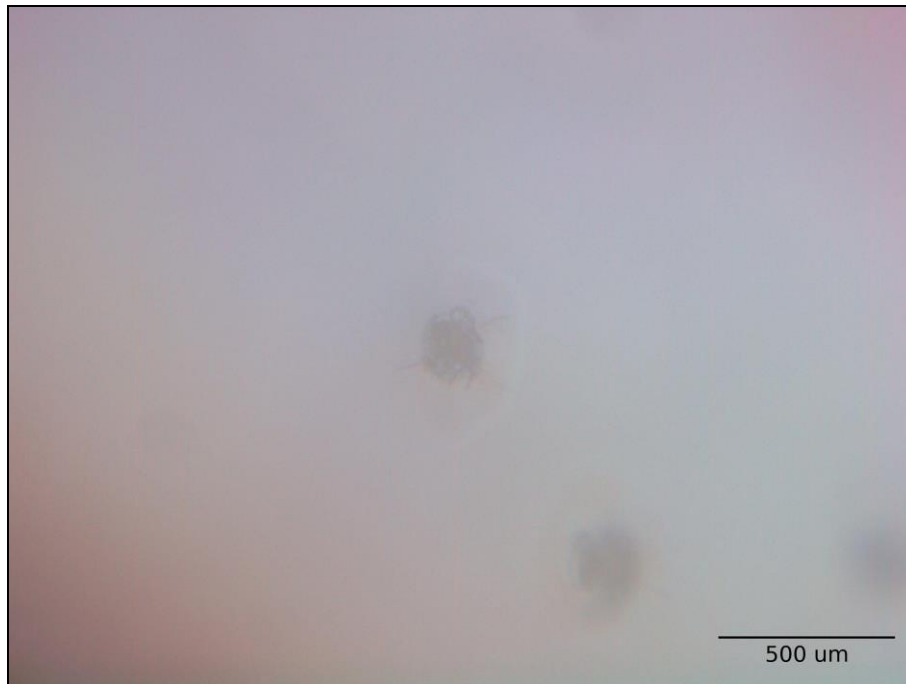
**Fig. 3 Typical polarizing surface damage morphology
(Fluence 28.4 J/cm², damage after 6 pulses)**

1. The provided threshold values are calculated for normal incidence in relation to the front surface in order to compare the LIDT values of different surfaces. The actual damaging fluence value on polarizing surface is $\cos(45^\circ) \approx 0.7$ times lower.
2. Per customer request, beam waist was always kept on the polarizing surface when translating the sample, therefore experimental fluence values for other surfaces are up to ~10% lower than provided in the measurement report (Rayleigh length was 28 mm).

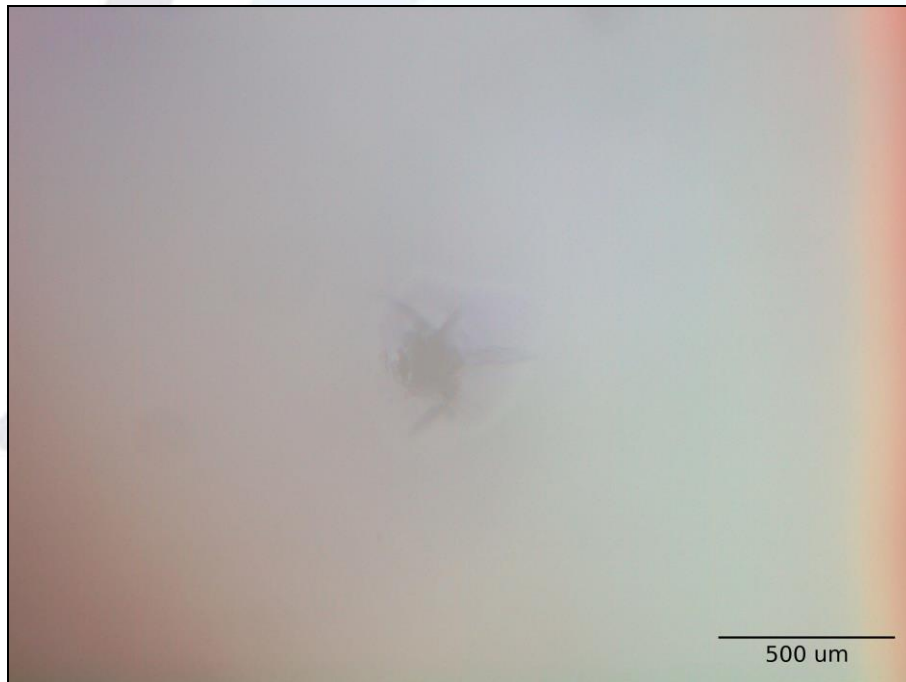
**Fig. 4 Typical polarizing surface damage morphology
(Fluence 31.7 J/cm², damage after 5 pulses)**

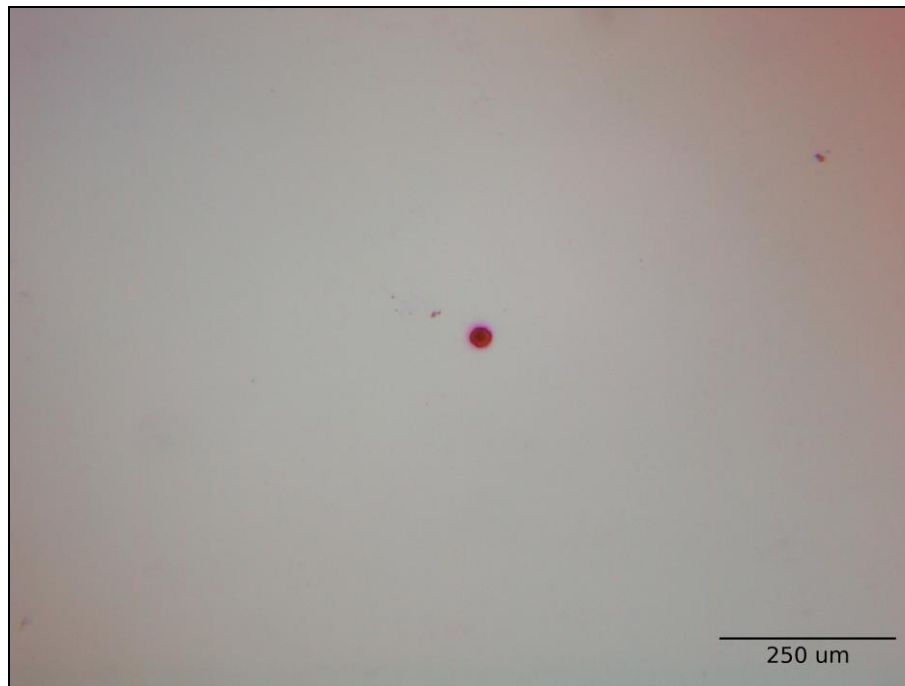
Fig. 5 Typical front surface damage morphology
(Fluence 27.3 J/cm^2 , damage after 1000 pulses)

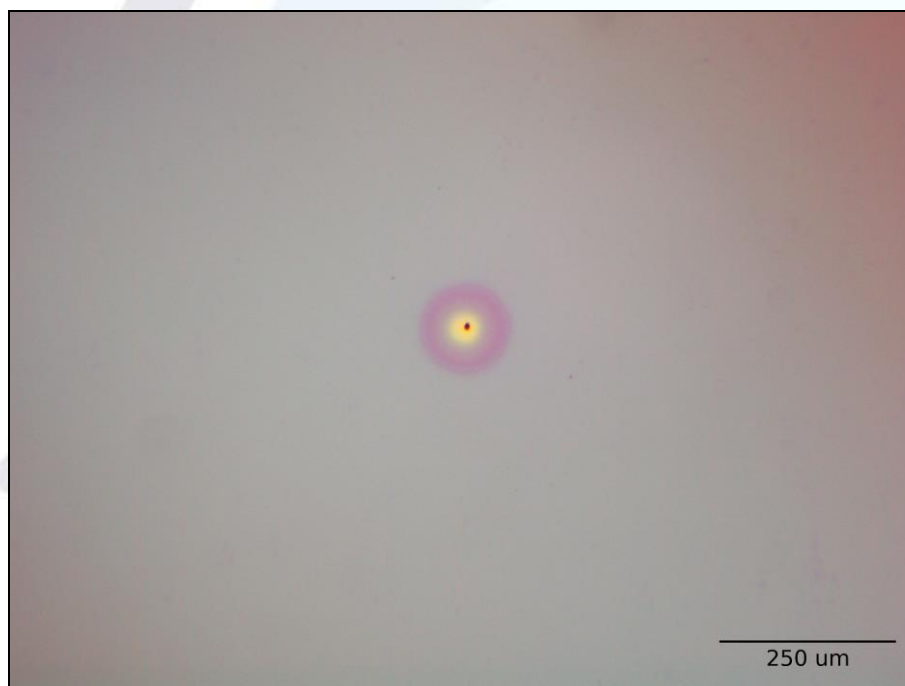
Fig. 6 Typical front surface damage morphology
(Fluence 42.7 J/cm^2 , damage after 11 pulses)

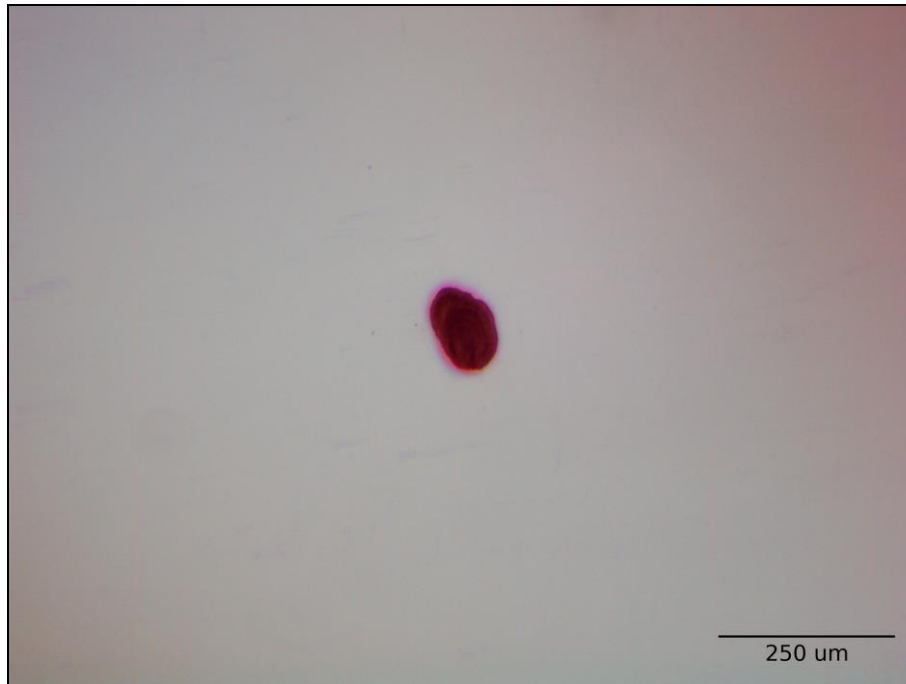
Fig. 7 Typical back surface damage morphology
(Fluence 27.2 J/cm^2 , damage after 1000 pulses)

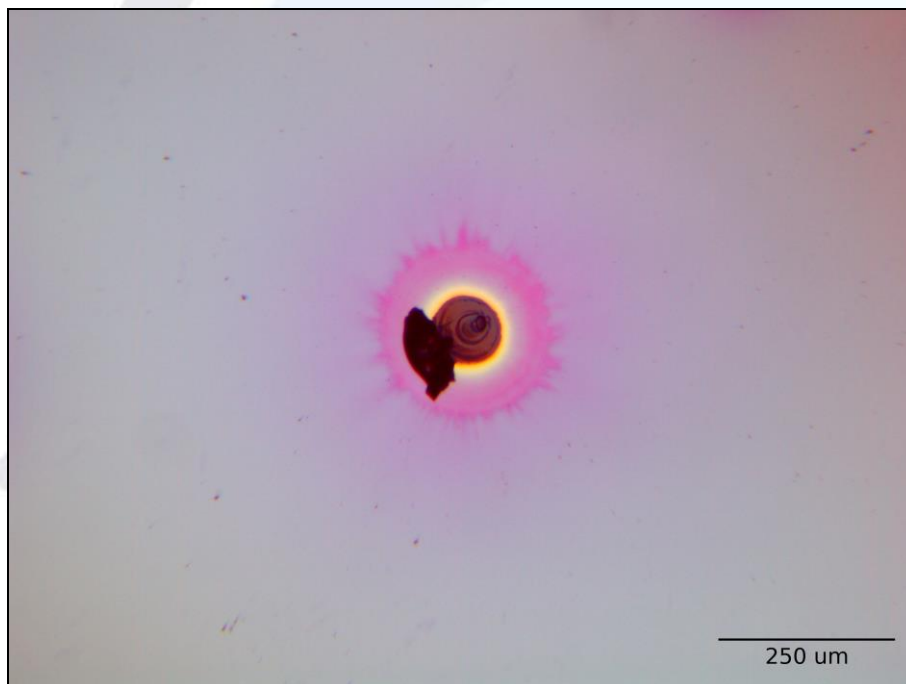
Fig. 8 Typical back surface damage morphology
(Fluence 37.8 J/cm^2 , damage after 27 pulses)
