Laser-Induced Damage Threshold (LIDT) Measurement Report

ISO 21254-2: S-on-1 Test Procedure

Sample: 1-OS-2-0254-5-[UBBHR]

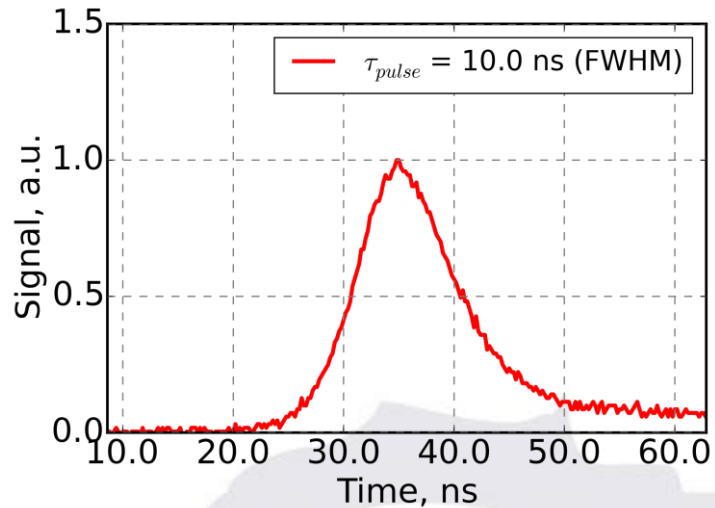
Fig. 1 Spatial beam profile in target plane (left) and oscilloscope trace (right)

Wavelength: 1064 nm
Angle of incidence: 45 deg.
Polarization state: linear P
Pulse repetition frequency: 20 Hz
Spatial beam profile in target plane: TEM₀₀
Longitudinal beam profile: Single mode (SLM)
Beam diameter in target plane ($1/e^2$): $214.3 \pm 2.6 \mu\text{m}$ (average from 64 pulses)
Pulse duration: 10.0 ± 0.5 ns

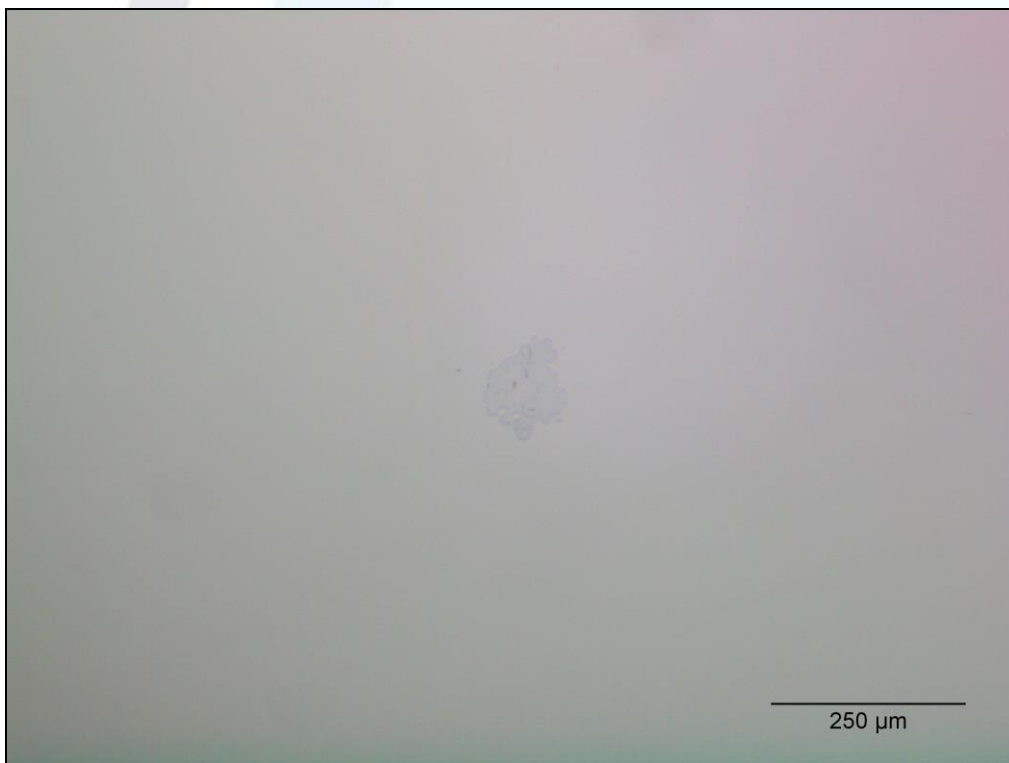
**Fig. 4 Typical damage morphology
(Fluence 2.52 J/cm², damage after 1000 pulses)**

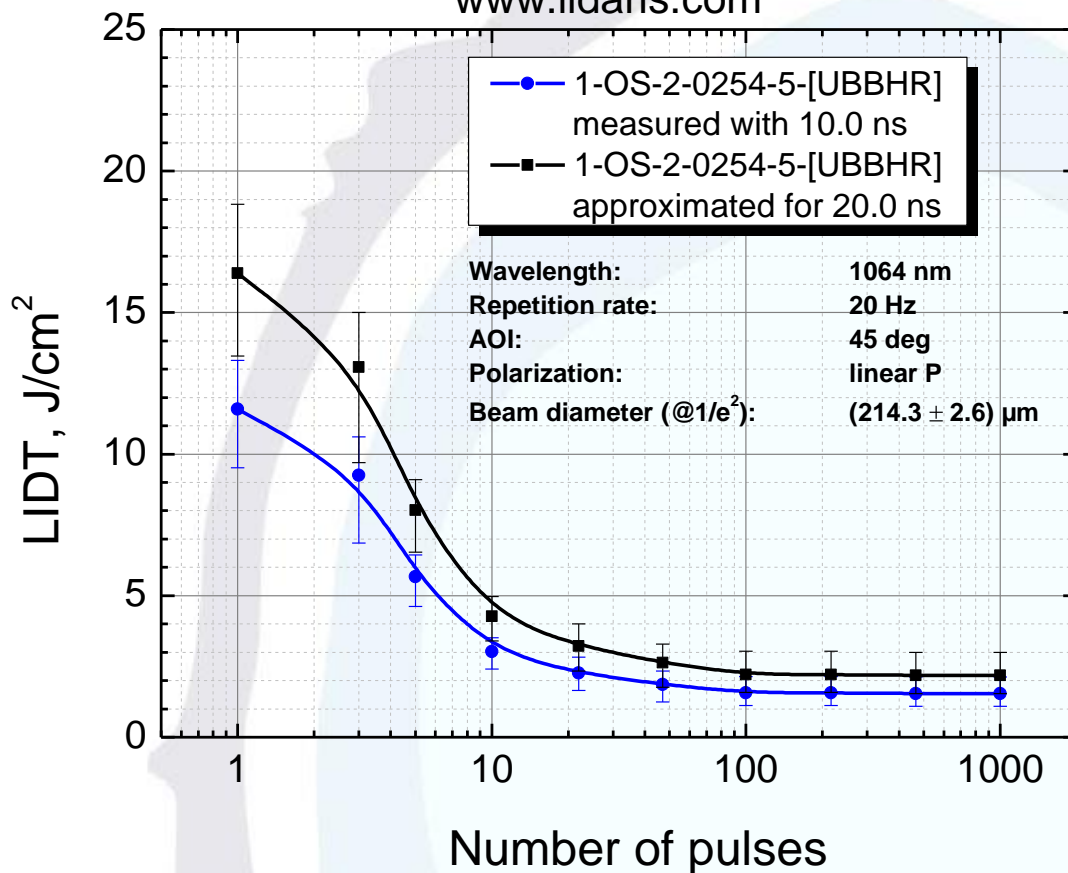
Fig. 5. Approximated characteristic damage curve.

Laser-Induced Damage Threshold (LIDT) results were approximated for 20.0 ns pulse duration from 10.0 ns pulse duration measurements using empirical square root of pulse duration law (see Table 2 and Fig. 5).

Test mode	Threshold, J/cm ²
1-on-1	13.47 ≤ 16.39 ≤ 18.83
1000-on-1	1.55 ≤ 2.18 ≤ 3.00
