TEST EQUIPMENT

LIDT TEST RESULTS

Table 1: Estimated LIDTs from fitting model for sample M0001948 LOT0068618 ID 71473.

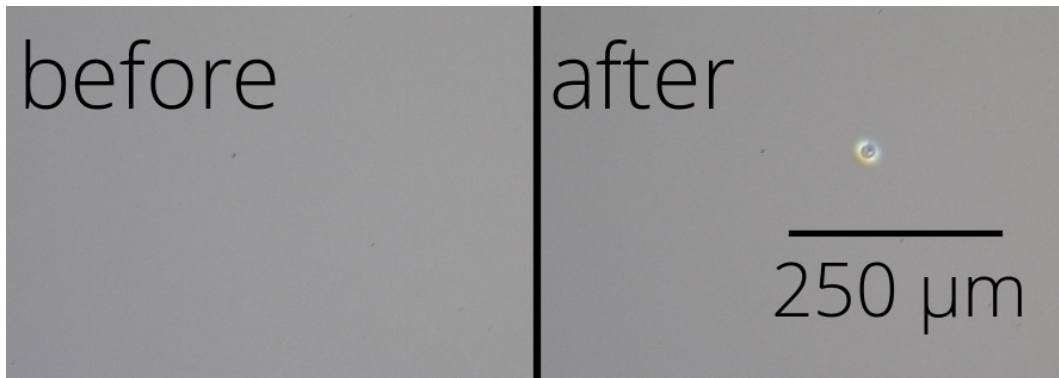
Figure 4. Typical damage morphology: fluence 16.3 J/cm², damage after 1000 pulse(s).

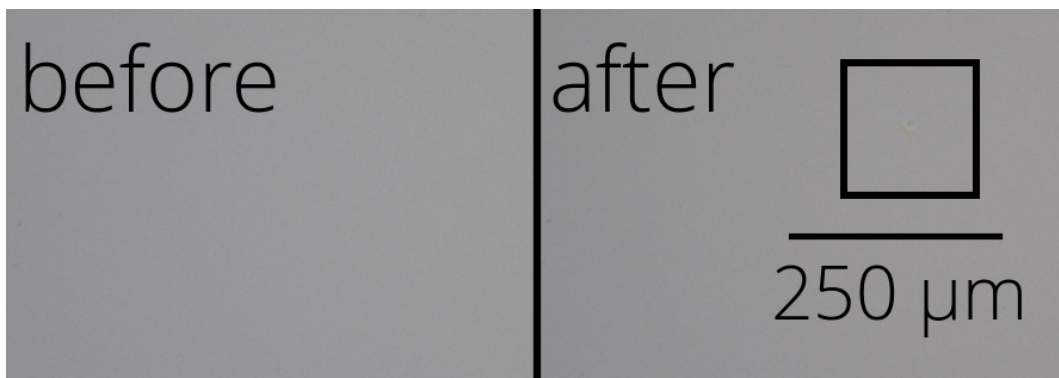
Figure 5. Typical damage morphology: fluence 17.4 J/cm², damage after 1000 pulse(s).

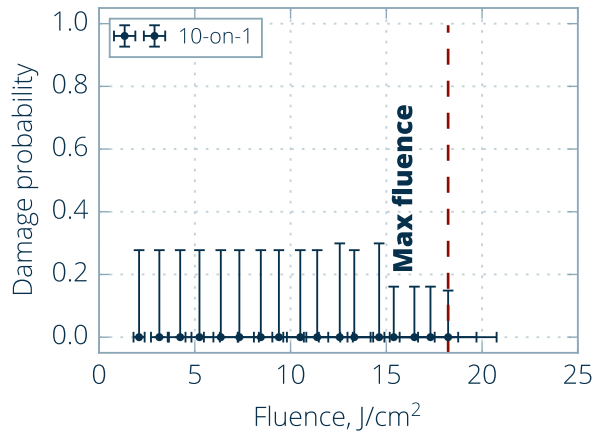
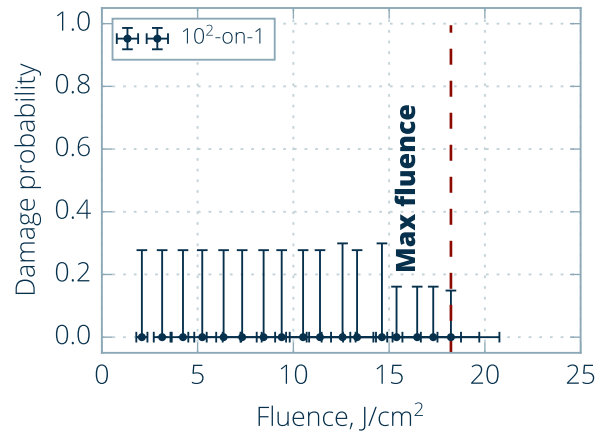
(a) 10-on-1

(b) 10²-on-1

(c) 10³-on-1

Figure 6. Damage probability plots. ⁶

TECHNICAL NOTE 2: No damages were found

No damages were found for this type of analysis, therefore, LIDT value could not be evaluated. LIDT value should be higher than maximum fluence value used in the test. This fluence value is written in the thresholds table.
