Laser-Induced Damage Threshold (LIDT) Measurement Report

ISO 21254-2: S-on-1 Test Procedure

Sample: 2-CPW-ZO-L/2-1030

Testing institute: Lidaris Ltd.
Saulėtekio al. 10,
LT-10223, Vilnius, Lithuania, EU

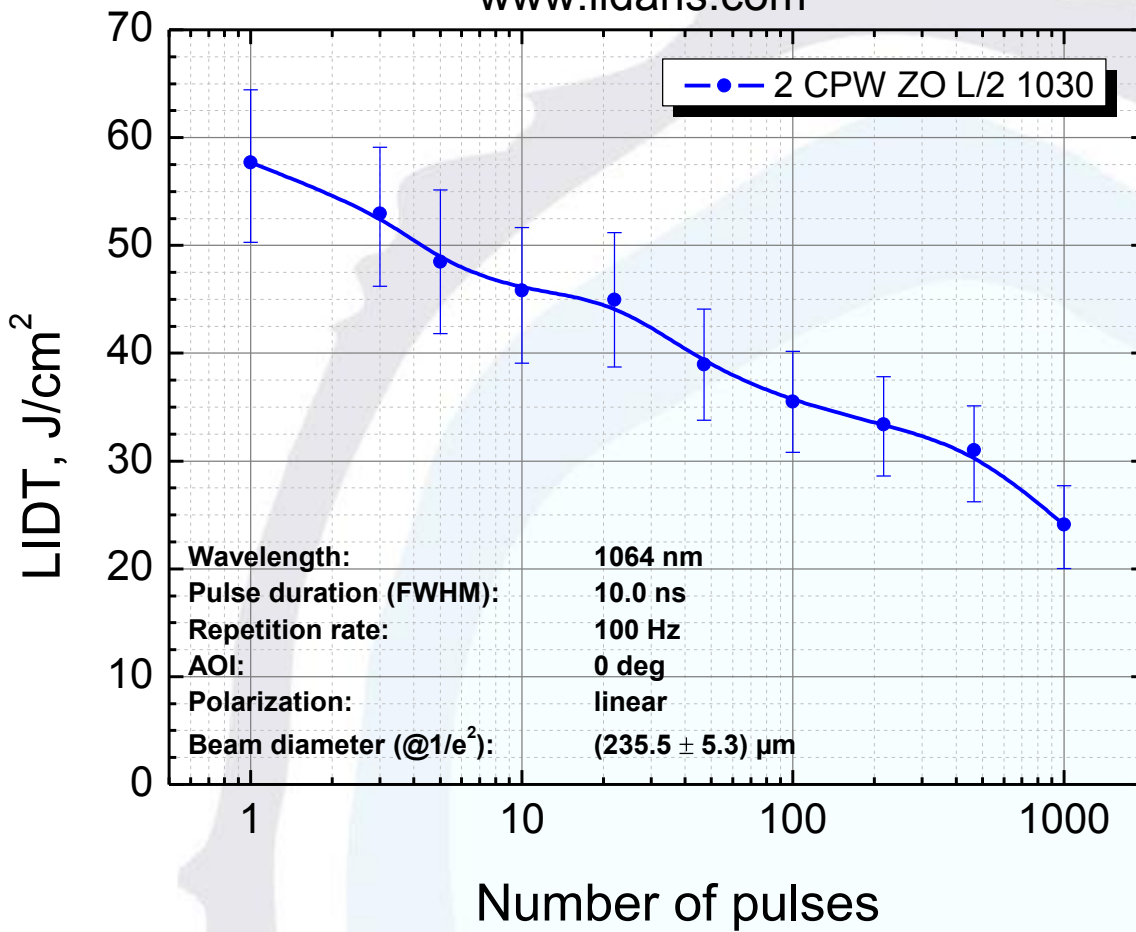
Test mode	Threshold, J/cm ²
1-on-1	50.30 ≤ 57.68 ≤ 64.43
1000-on-1	20.02 ≤ 24.12 ≤ 27.73

Fig. 2 Characteristic damage curve.
