TEST EQUIPMENT

LIDT TEST RESULTS

Table 1: Estimated LIDTs from fitting model for sample M0050994.

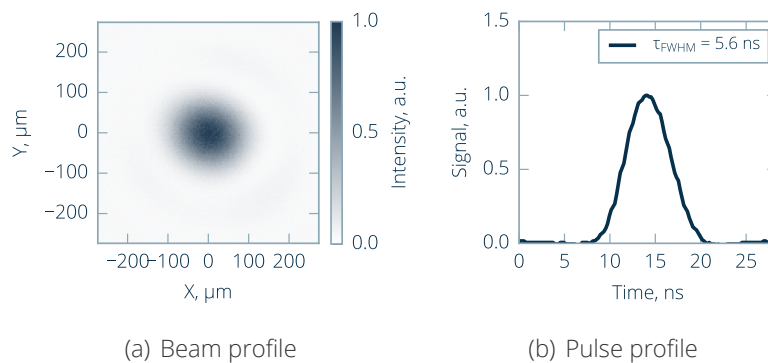
Type	Q-switched, seeded Nd:YAG
Manufacturer	InnoLas Laser II
Model	SpitLight Hybrid
Central wavelength	355.0 nm
Angle of incidence	55.8 deg
Polarization state	Linear P
Pulse repetition frequency	100 Hz
Spatial beam profile in target plane	TEM00
Beam diameter in target plane (1/e ²)	(233.9 ± 2.4) μm
Longitudinal pulse profile	Single longitudinal mode
Pulse duration (FWHM)	(5.6 ± 0.3) ns
Pulse to pulse energy stability (SD)	1.1 %

Figure 1. Laser parameters used for measurements.

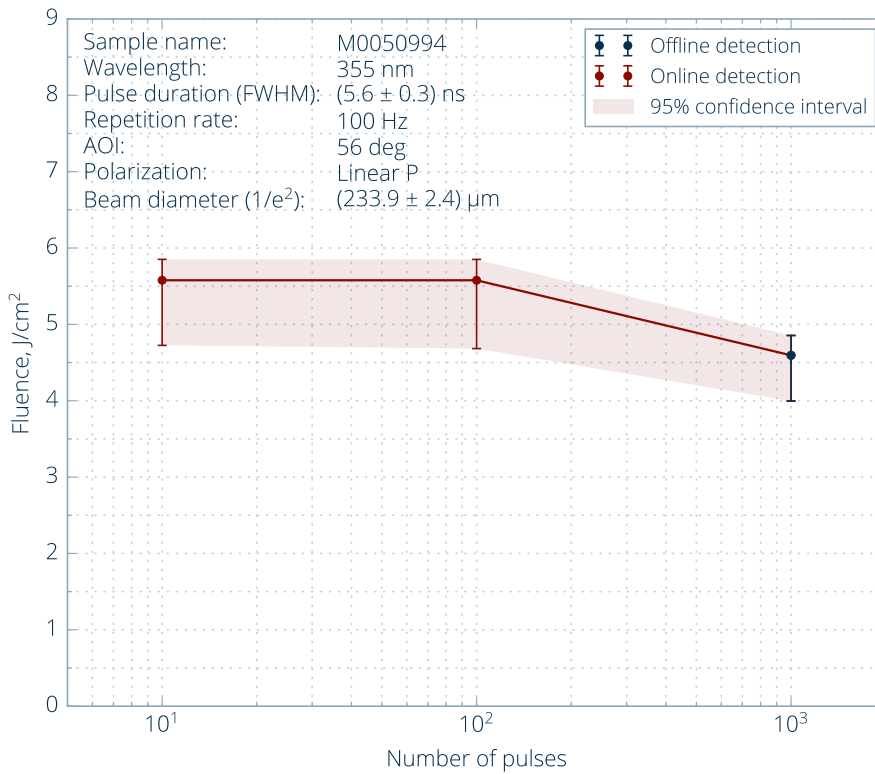
Figure 2. Characteristic damage curve.

10 ³ -on-1	4.59 ^{+0.26} / _{-0.60} J/cm ²	5.12 ^{+0.29} / _{-0.67} J/cm ² (scaled to 7.0 ns)
-----------------------	--	---

Test mode	Threshold (Offline detection - microscopy)	Threshold (Offline detection - microscopy) scaled to 7.0 ns	Threshold (Online detection - scattering)	Threshold (Online detection - scattering) scaled to 7.0 ns
10-on-1	-	-	5.58 ^{+0.27} / _{-0.85} J/cm ²	6.22 ^{+0.30} / _{-0.95} J/cm ²
10 ² -on-1	-	-	5.58 ^{+0.27} / _{-0.89} J/cm ²	6.22 ^{+0.30} / _{-1.00} J/cm ²
10 ³ -on-1	4.59 ^{+0.26} / _{-0.60} J/cm ²	5.12 ^{+0.29} / _{-0.67} J/cm ²	4.59 ^{+0.26} / _{-0.60} J/cm ²	5.12 ^{+0.29} / _{-0.67} J/cm ²

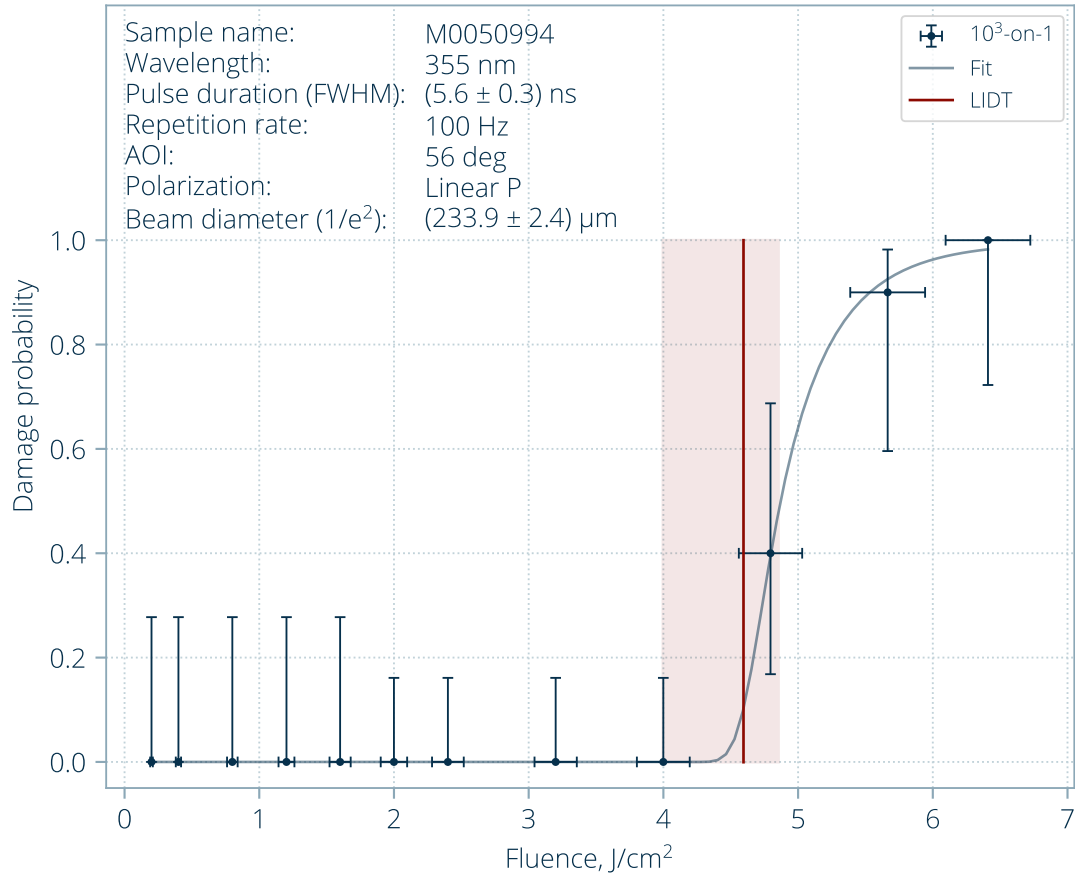
(a) 10^3 -on-1

Figure 3. Damage probability plot.

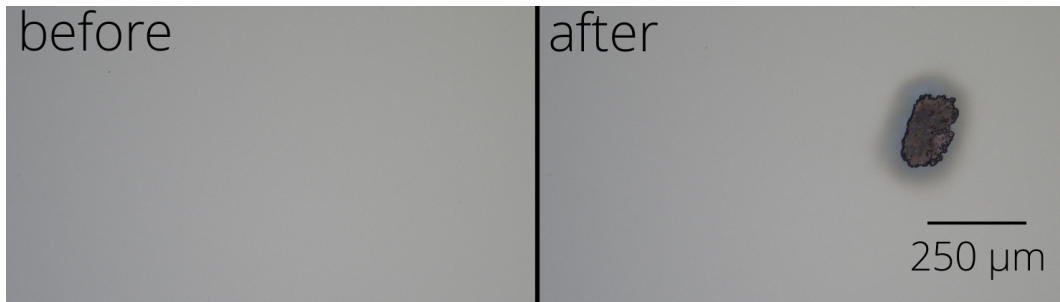
Figure 4. Typical damage morphology: fluence 4.73 J/cm^2 , damage after 222 pulse(s).

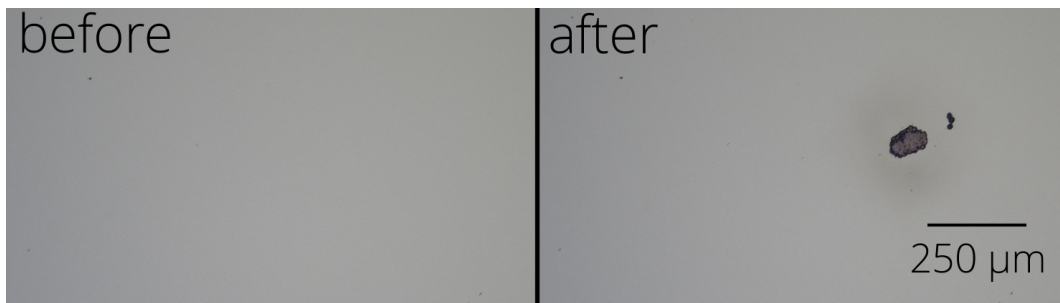
Figure 5. Typical damage morphology: fluence 6.19 J/cm^2 , damage after 10 pulse(s).

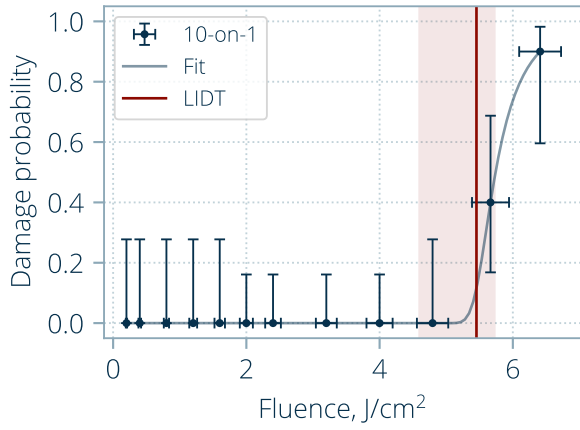
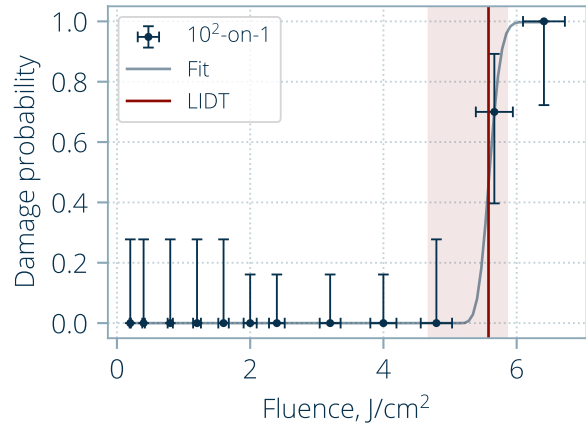
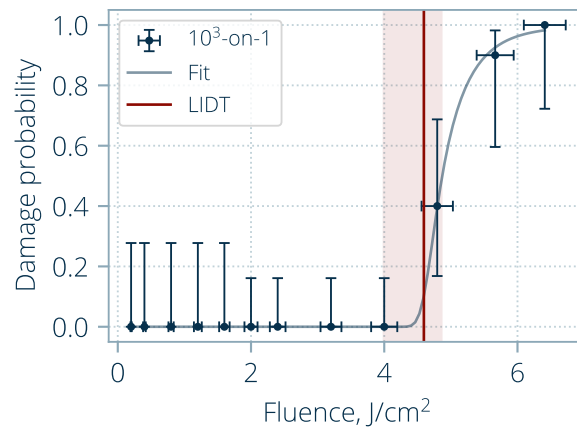
(a) 10-on-1

(b) 10²-on-1

(c) 10³-on-1

Figure 6. Damage probability plots.

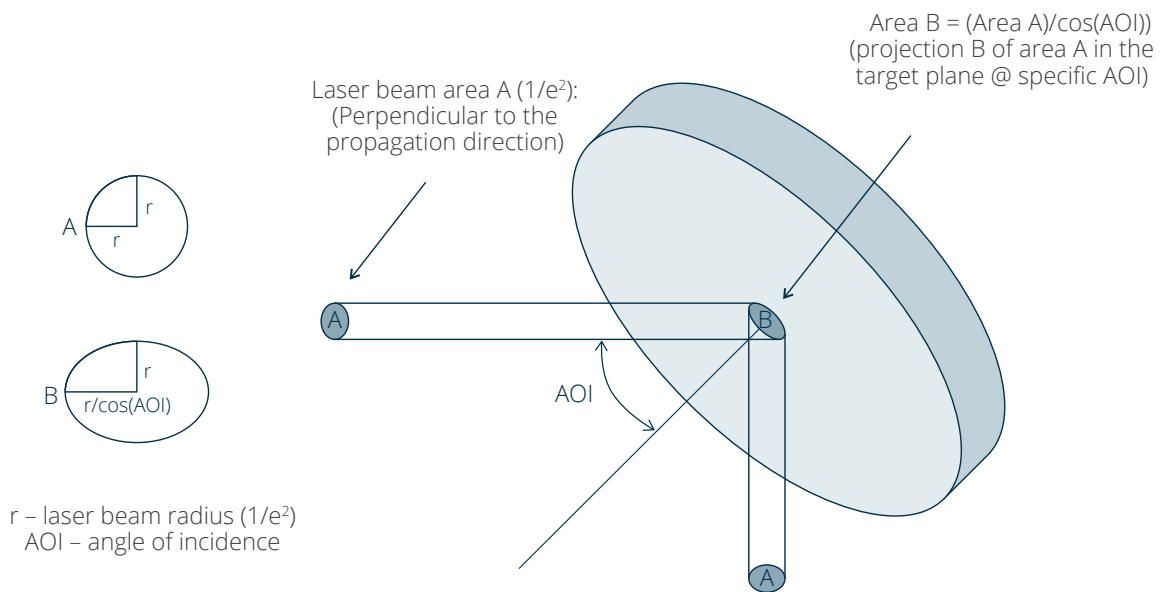
According to the ISO 21254-2:2011 standard, for spatial beam profiling perpendicular to the direction of beam propagation and angles of incidence differing from 0 degrees, the cosine of the angle of incidence is included in the calculation of the effective area, which leads to correct evaluation of laser fluence at different angles of incidence (Figure 7).

Figure 7. Oblique incidence.
